Visual Observations

DAM NAME ROME DAM
STATE ID 219-1082 Section A Hazard Code C
COUNTY ESSEX Inspection Date: 9/14/2015
NEAREST DS CITY/TOWN AUSABLE FORKS Inspector(s): DC/CS/TW/KB
OWNER'S NAME TOWN OF JAY
DOWNSTREAM HAZARD HIGH TOWNSHIP JAY

**Re: Rome Dam, DEC ID#: 219-1082, Class C (High Hazard)
Town of Jay, Essex County**

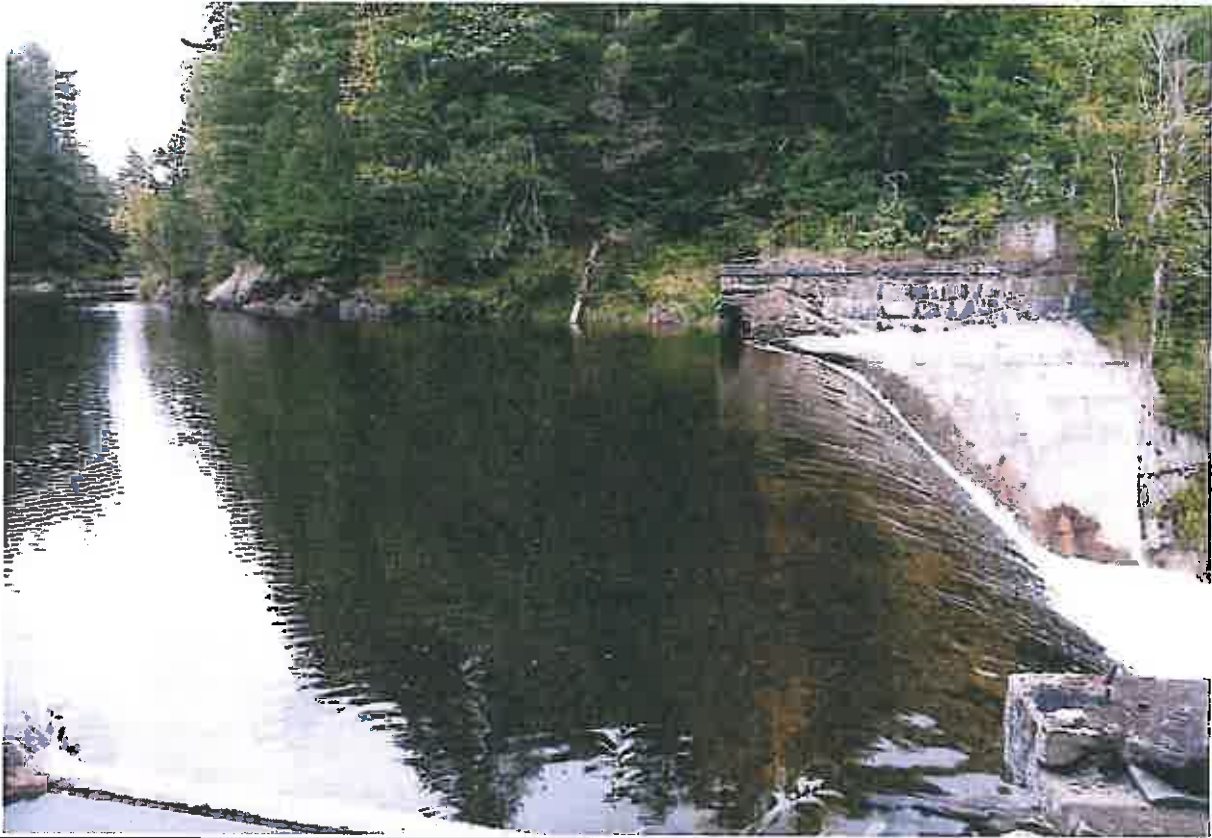
Photo 1 Dam ID# 219-1082 Rome Dam 9/15/15
Looking west across spillway

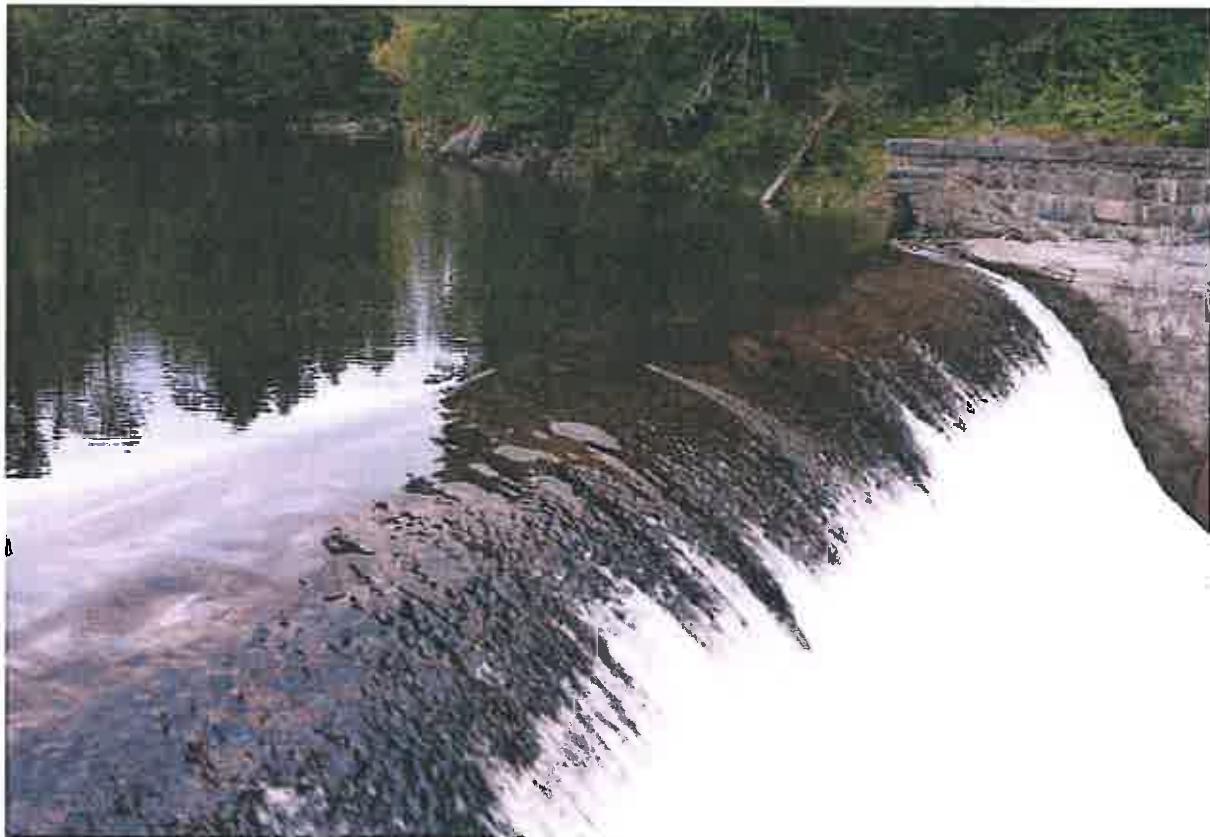
Photo 2 Dam ID# 219-1082 Rome Dam 9/14/15
Spillway crest

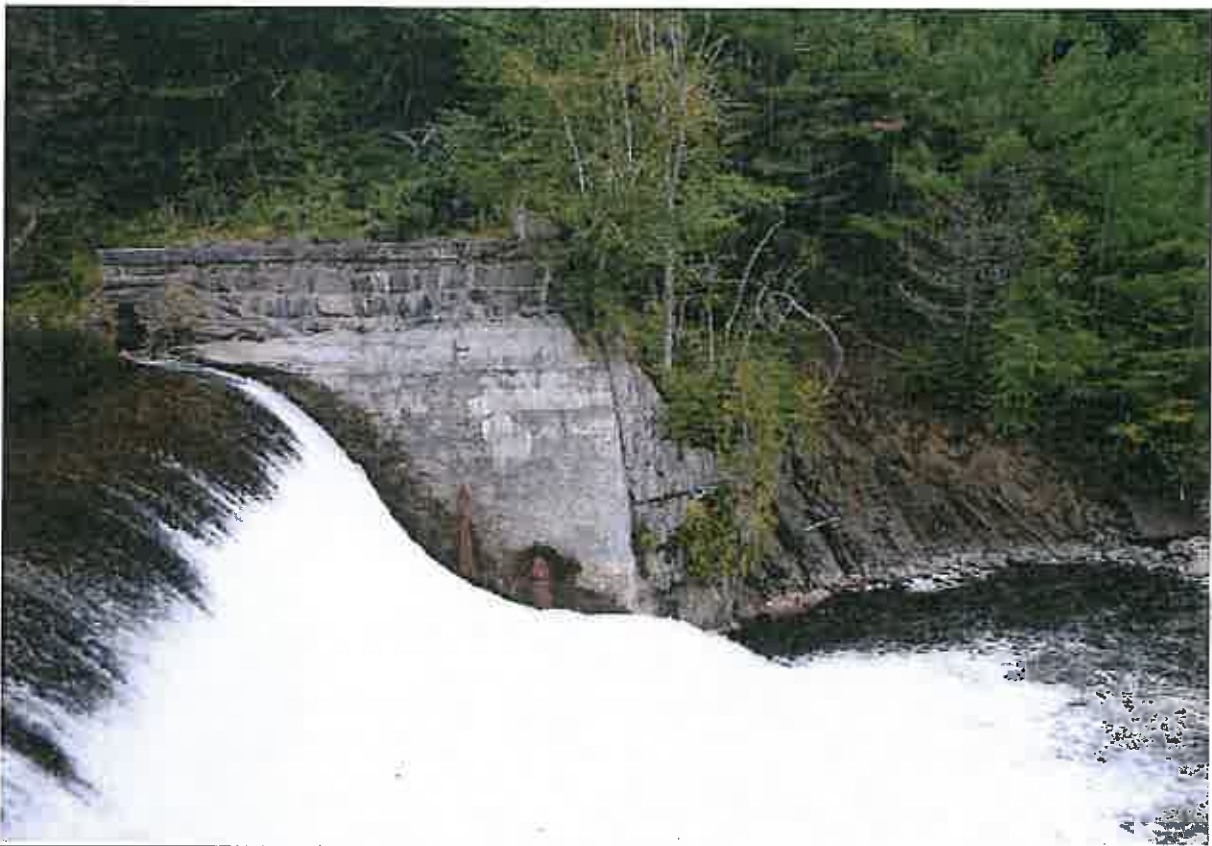
Photo 3 **Dam ID# 219-1082** **Rome Dam** **9/14/15**
Left spillway sidewall

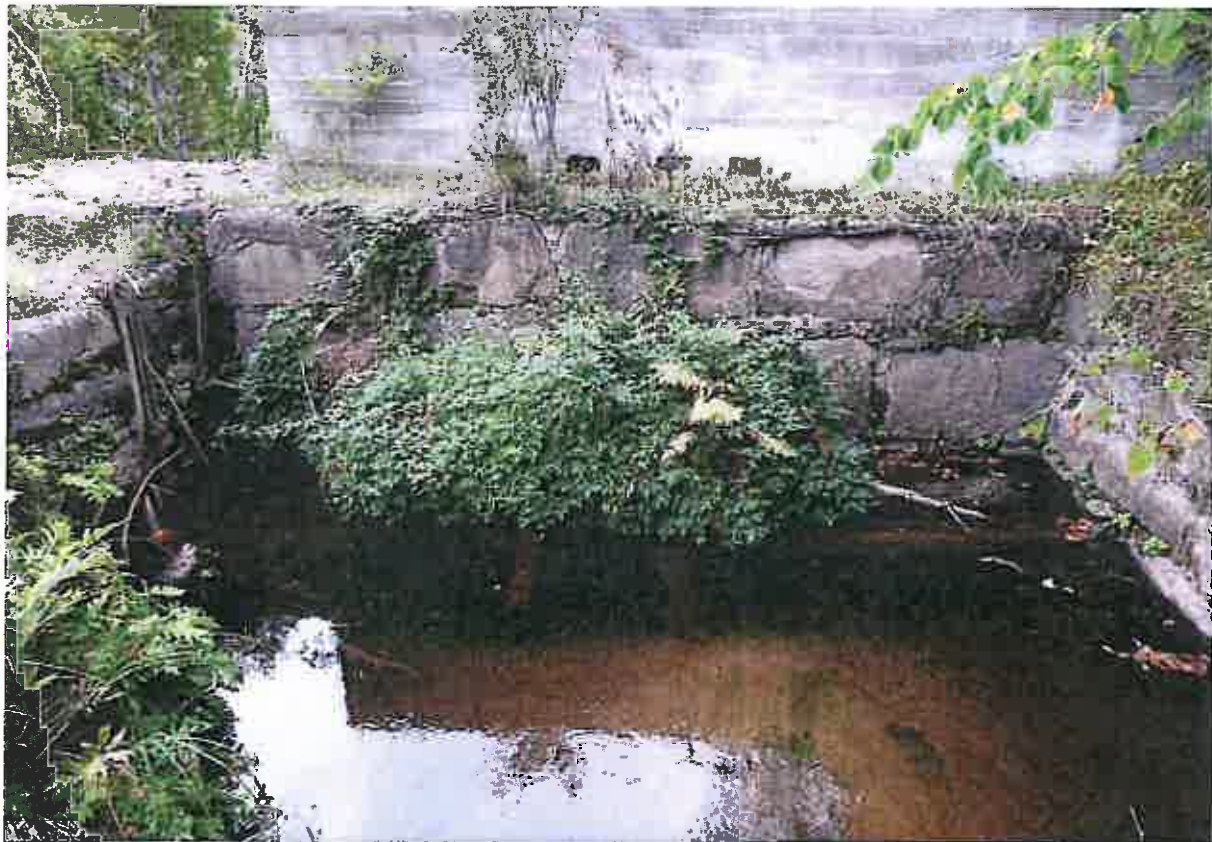
Photo 4 **Dam ID# 219-1082** **Rome Dam** **9/14/15**
Right penstock intake

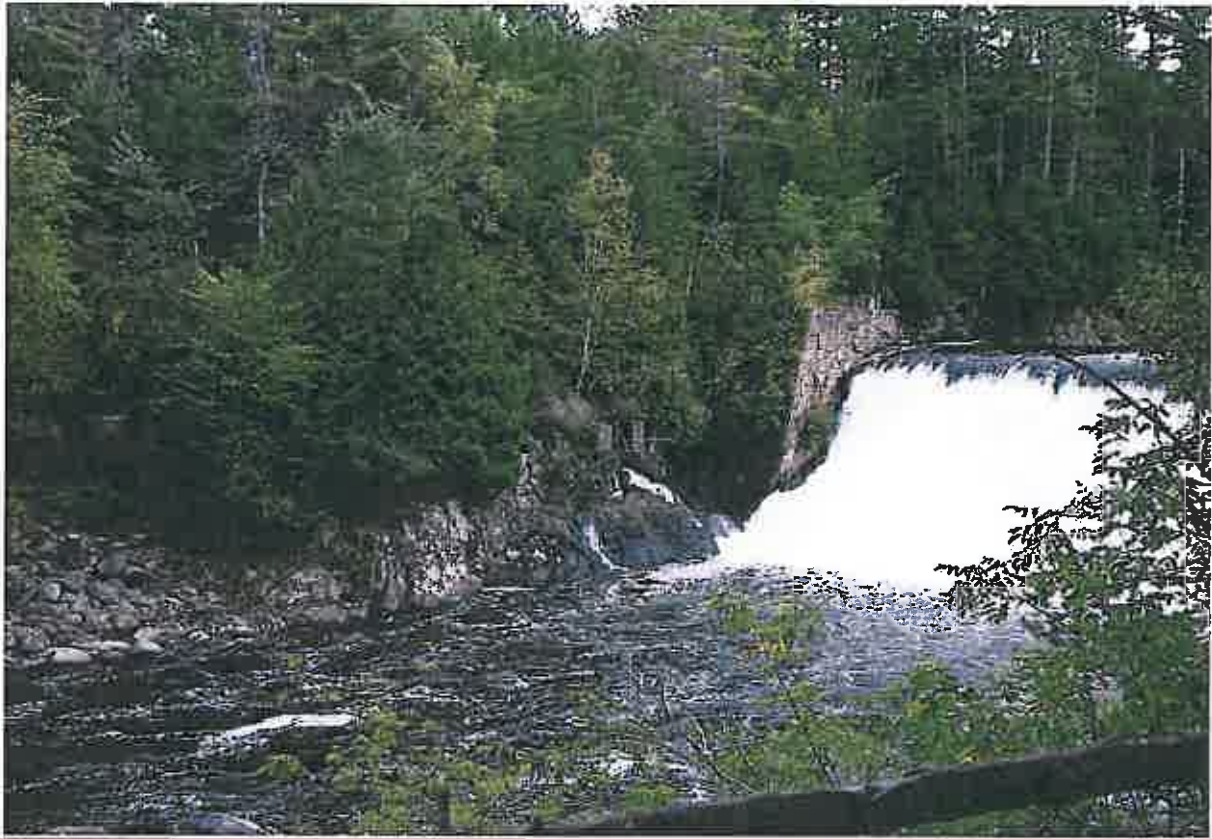
Photo 5 **Dam ID# 219-1082** **Rome Dam** **9/14/15**
Looking southeast at right abutment, penstock

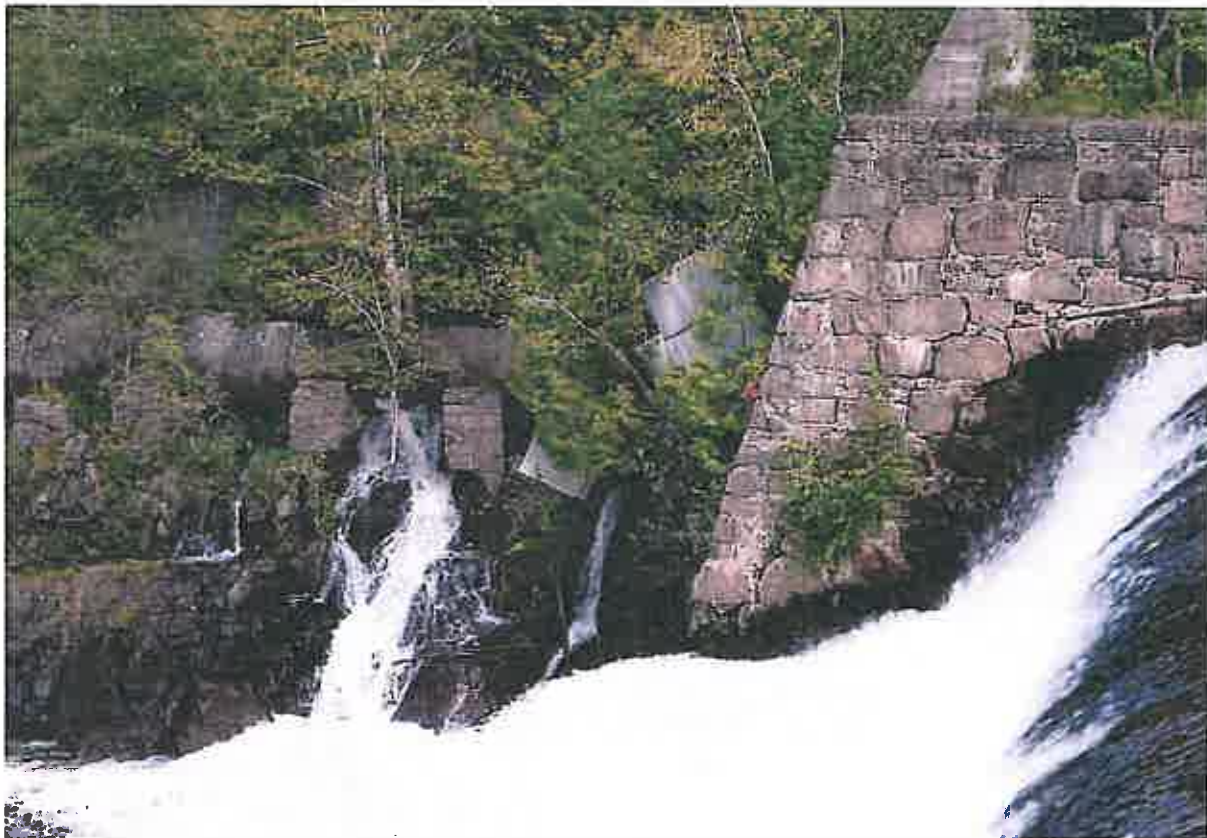
Photo 6 **Dam ID# 219-1082** **Rome Dam** **9/14/15**
Right spillway wall - note leakage through right gate, missing stone and cracks in sidewall

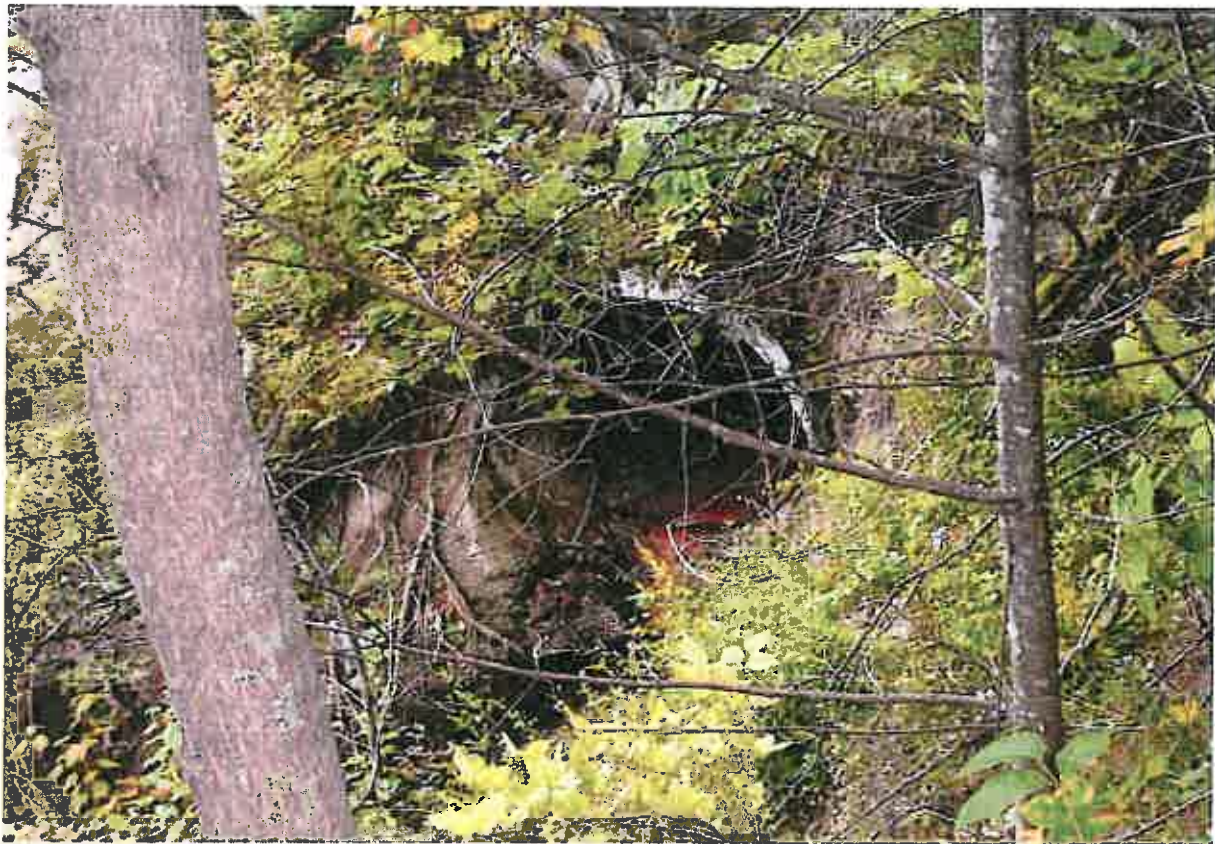
Photo 7 Dam ID# 219-1082 Rome Dam 9/14/15
Left penstock

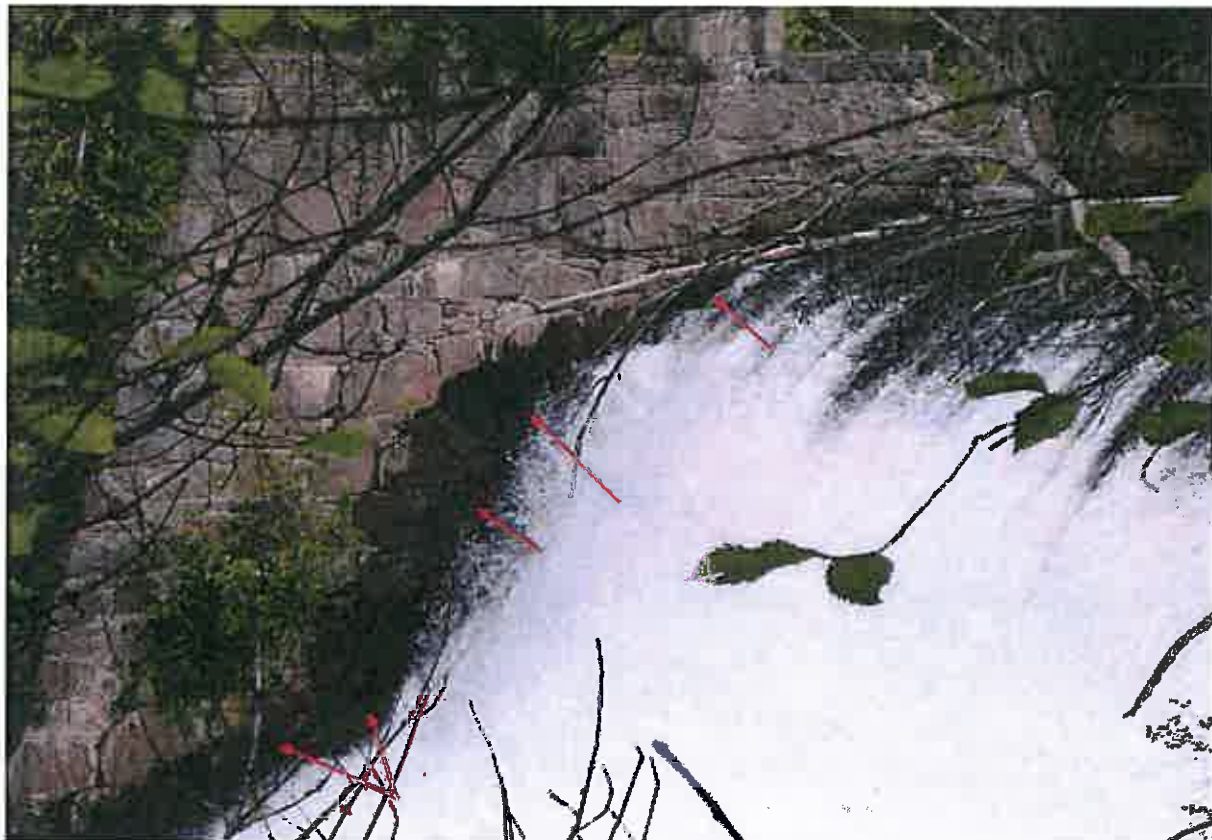
Photo 8 Dam ID# 219-1082 Rome Dam 9/14/15
Cracks, missing stone along sidewall

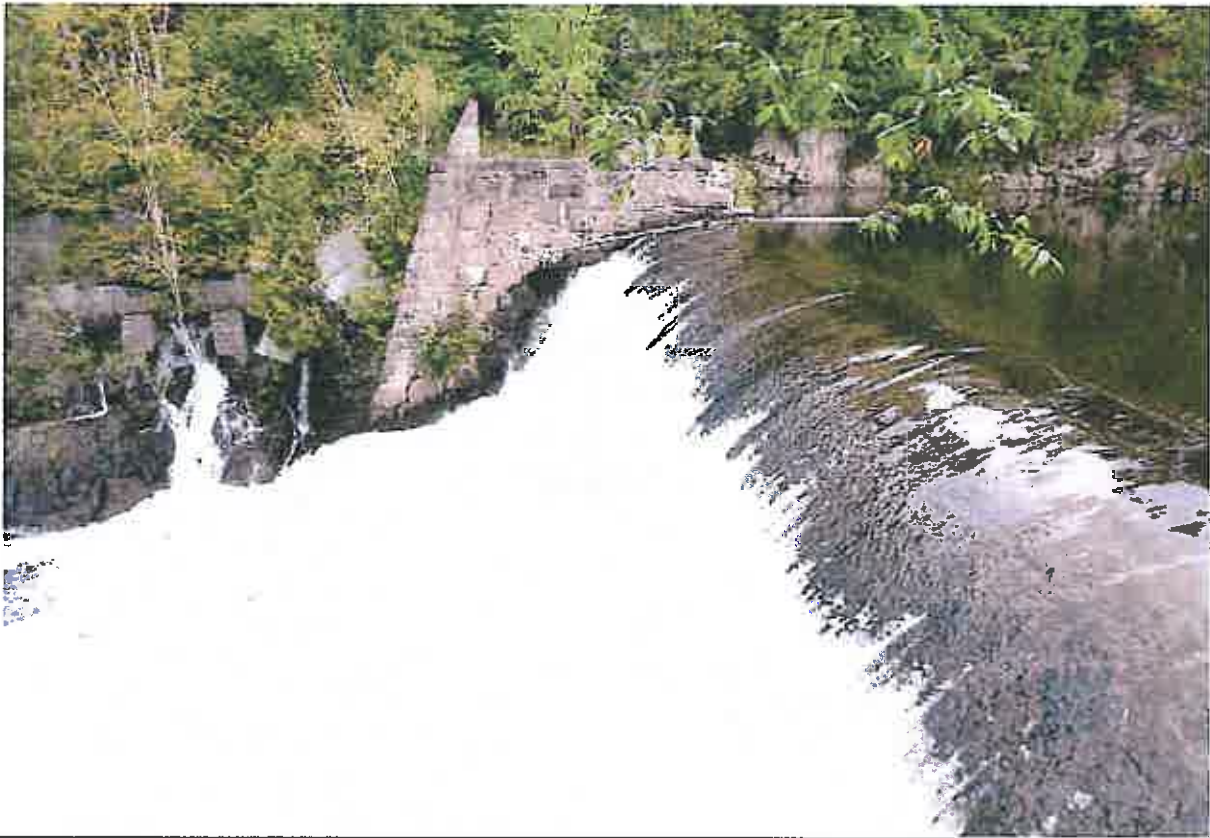
Photo 9 **Dam ID# 219-1082** **Rome Dam** **9/14/15**
Looking east across spillway

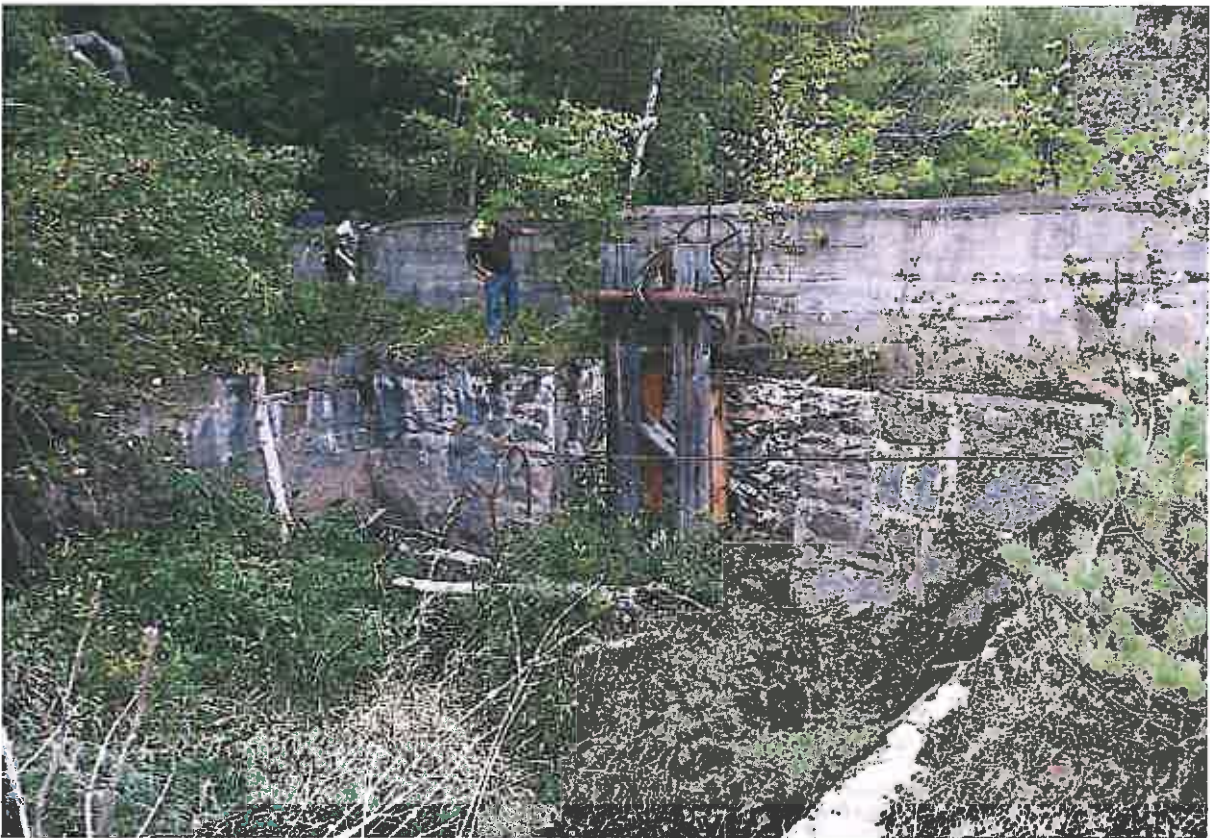
Photo 10 **Dam ID# 219-1082** **Rome Dam** **9/14/15**
Left penstock intake

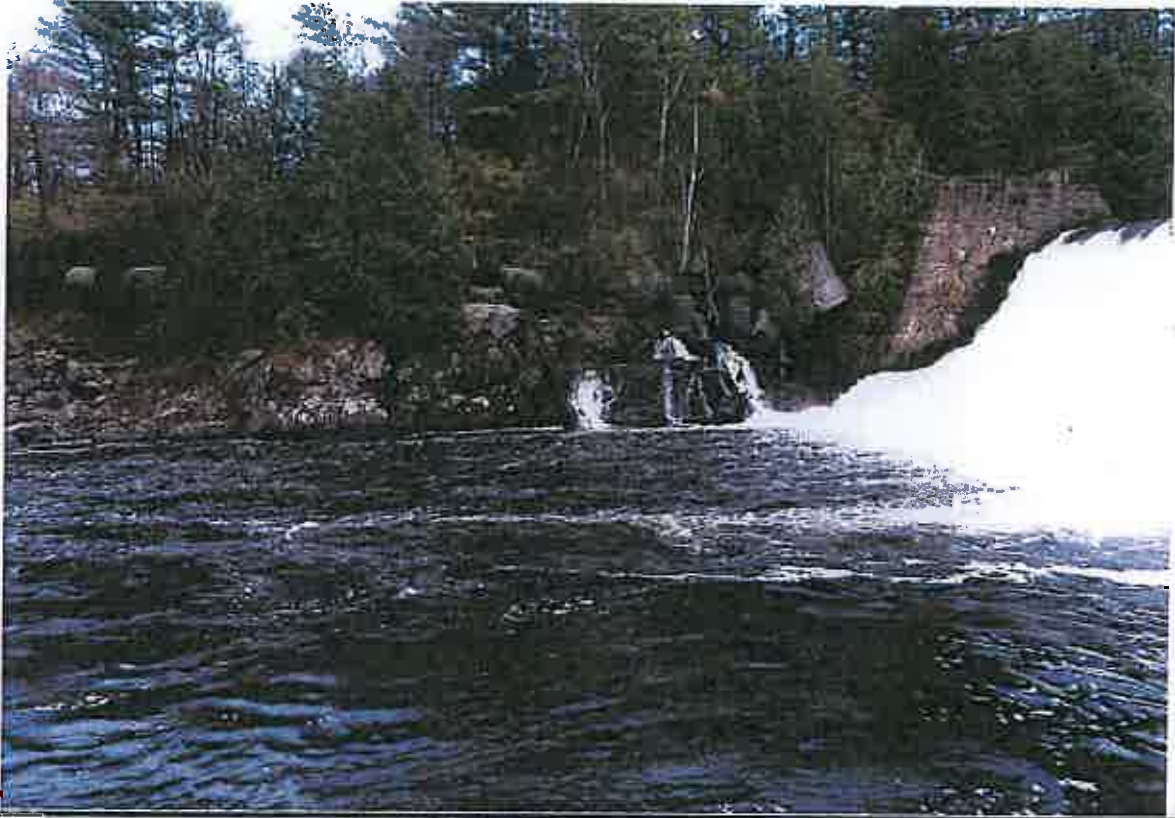
Photo 2 Dam ID# 219-1082 Rome Dam 10/22/13
Right (south) abutment/ penstock - leakage through penstock

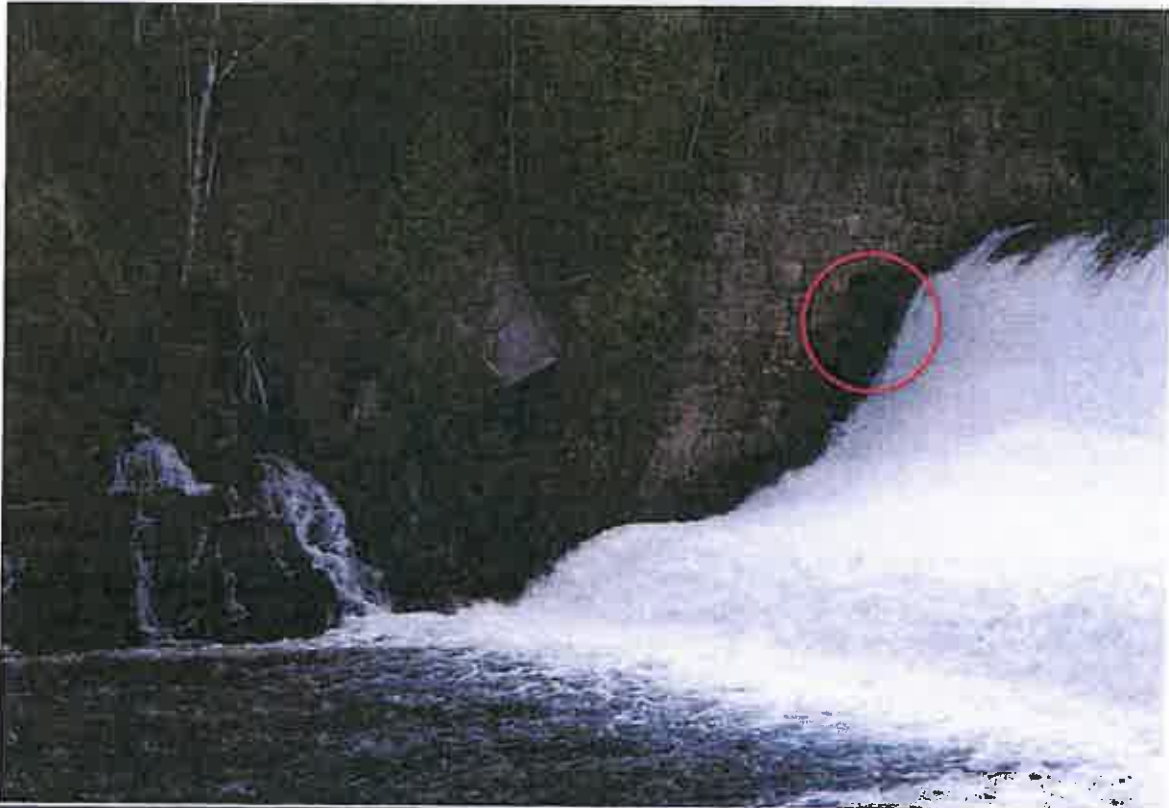
We inspected the left side of the dam by traversing an overpass near West Church Street and walking along the north bank up to the dam. Viewed from the left bank, it appears that at least one large stone is missing from the right abutment and smaller stones may also be missing. In addition, mortar is missing from many joints. Given the nearness of this void to the spillway flow, water is likely entering the openings causing continuing deterioration. This area must be monitored during your routine inspections for any movement or other change in condition.

Rgt. Abutment Appears stones missing from north (spillway side) abutment face, approx. 6-ft. down from spillway crest;

Missing mortar between stone masonry joints

Photo 3 Dam ID# 219-1082 Rome Dam 10/22/13
Stone(s) missing in abutment, missing mortar along joints

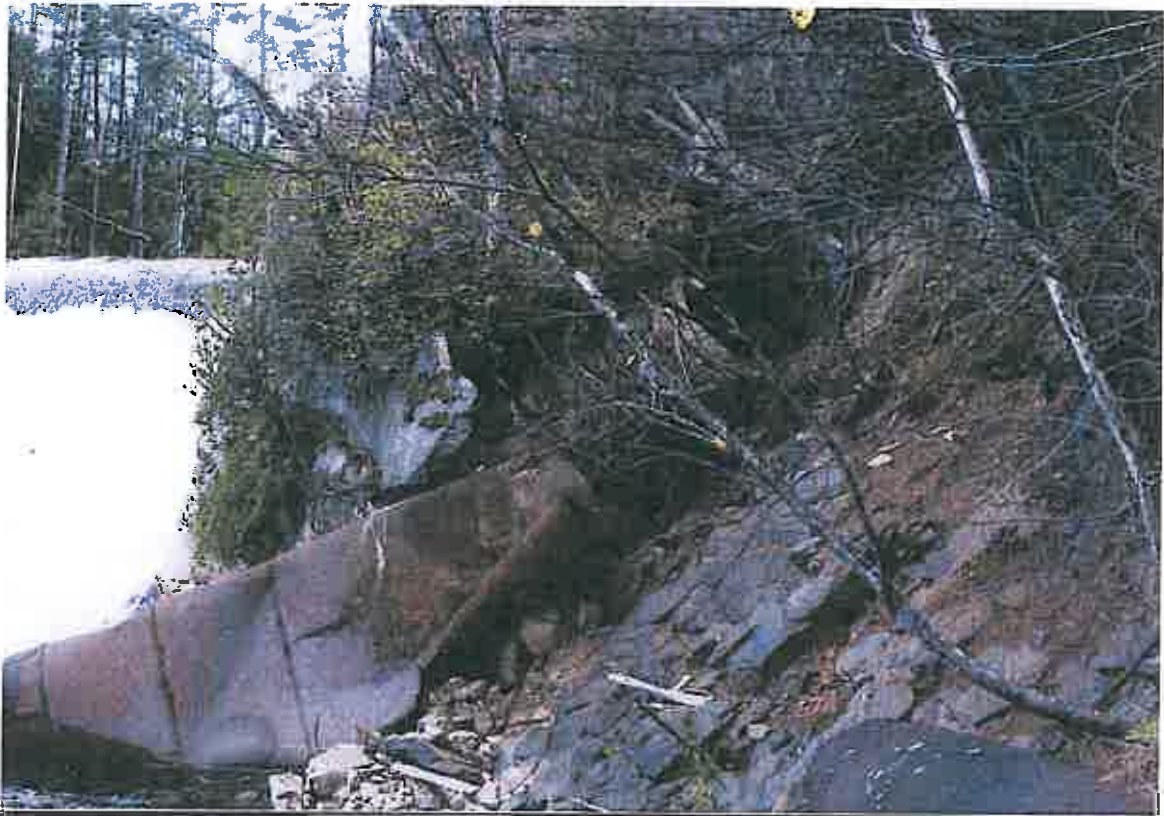
The left abutment intake chamber is filled with significant debris. In addition the downstream training wall is collapsed, erosion is occurring along the downstream bank and trees and other vegetation are growing across most of the abutment.

Left Abutment Downstream face of abutment and downstream bank has eroded;

Photo 4 Dam ID# 219-1082 Rome Dam 10/22/13
Left (north) abutment downstream face - downstream concrete training wall collapsed

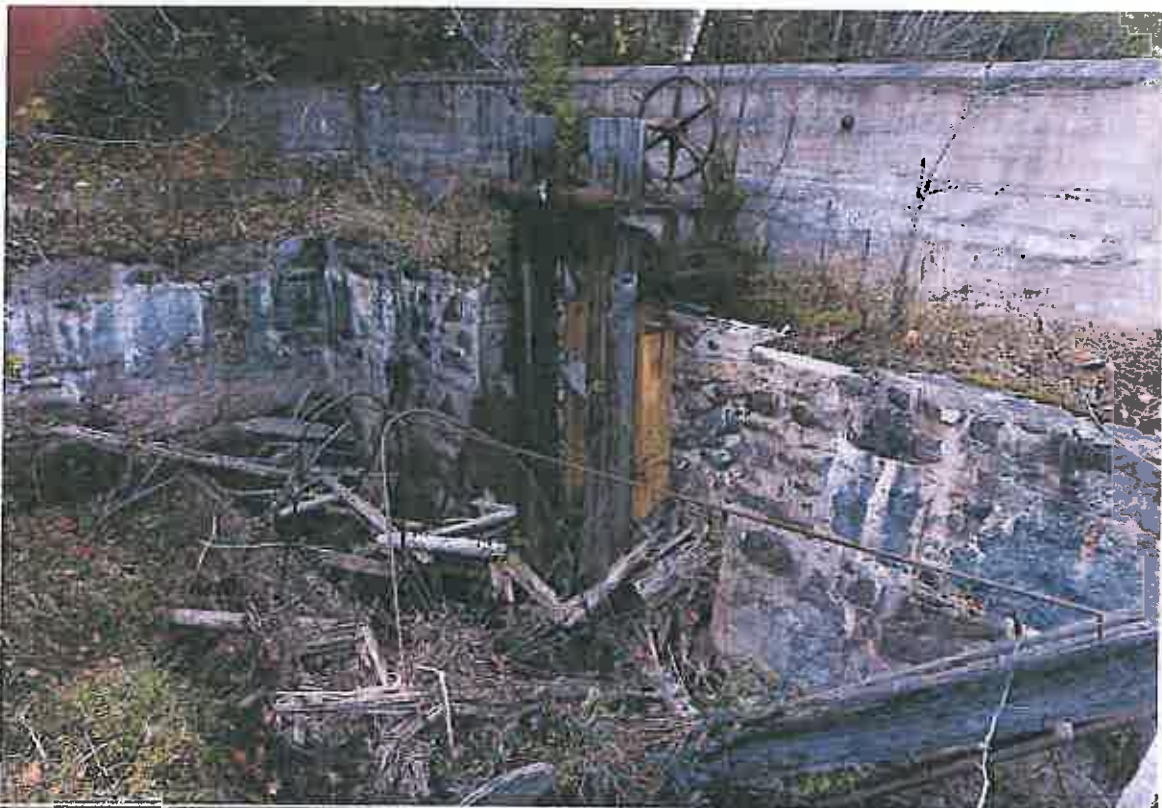
Photo 5 Dam ID# 219-1082 Rome Dam 10/22/13
Left gate, intake structure

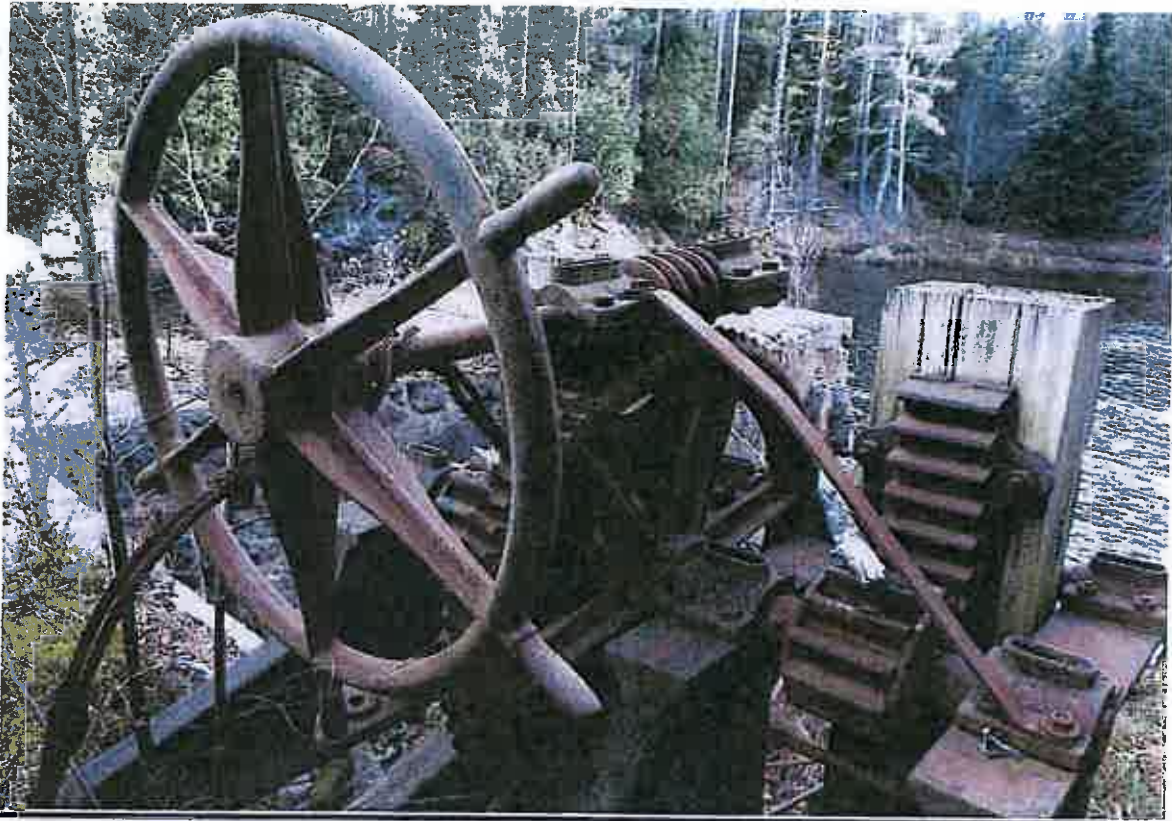
Photo 6 **Dam ID# 219-1082** **Rome Dam** **10/22/13**
Gate operator

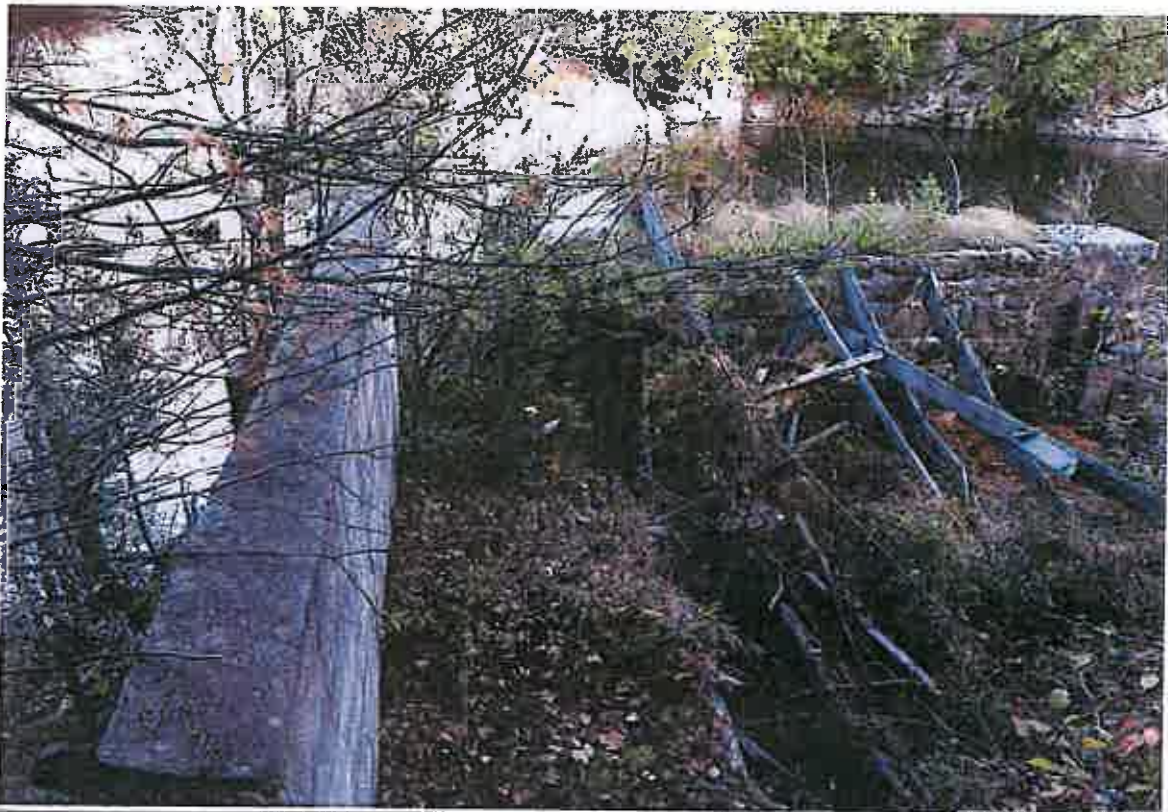
Significant debris upstream of gate:

Photo 7 **Dam ID# 219-1082** **Rome Dam** **10/22/13**
Looking across left intake from bank

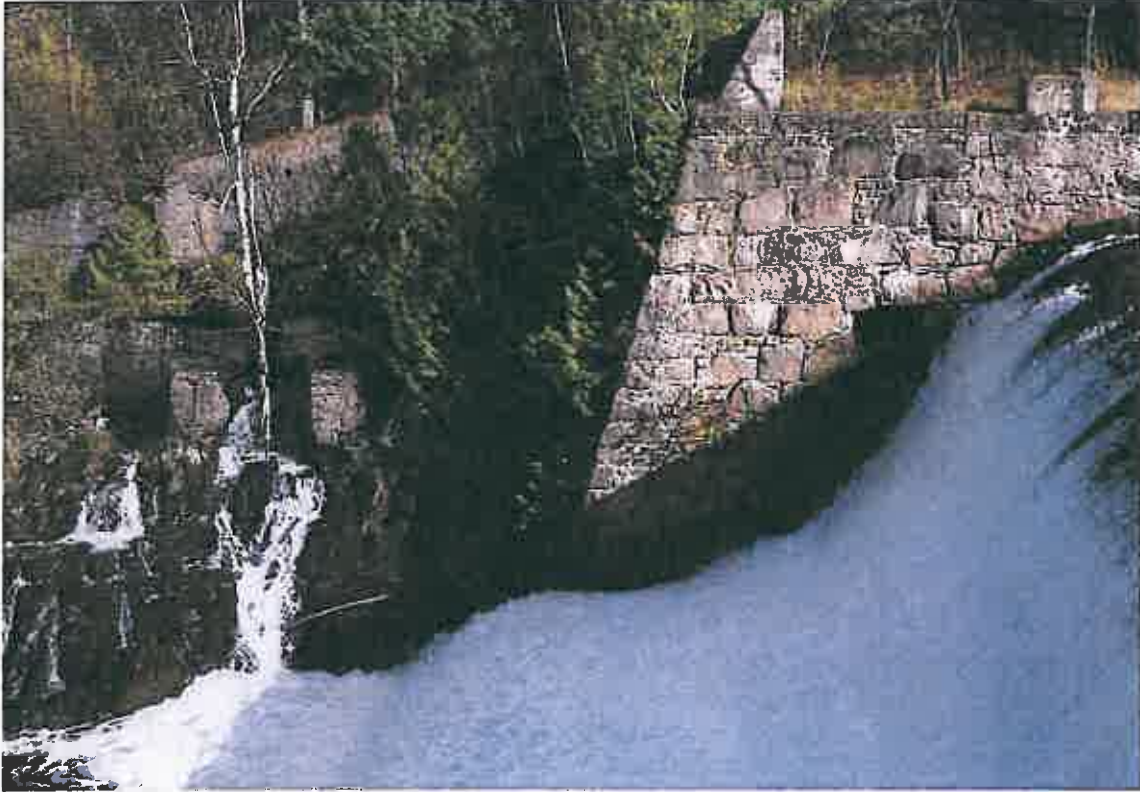
Photo 8 **Dam ID# 219-1082** **Rome Dam** **10/22/13**
Right abutment - note missing stone, mortar, leakage

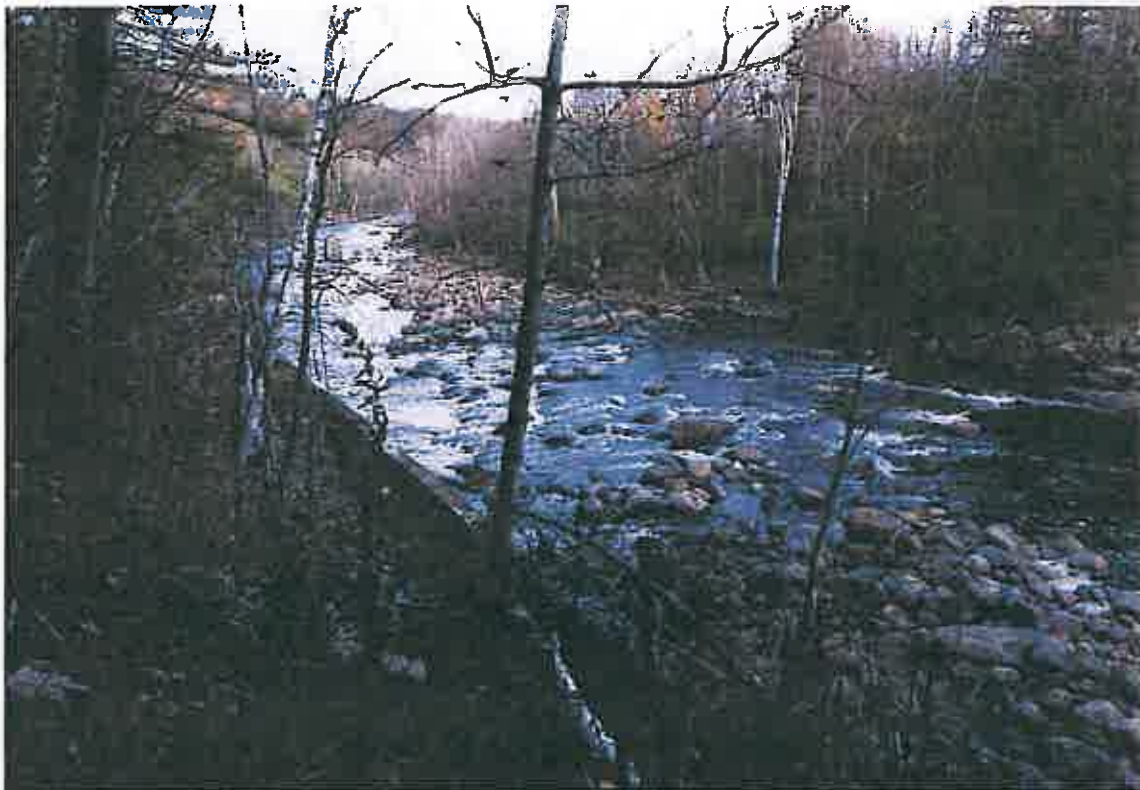
Photo 9 **Dam ID# 219-1082** **Rome Dam** **10/22/13**
Outlet channel
