Rome Dam Engineering Study (NY ID #219-1082)

Jay, New York February 28, 2017

MMI #5810-01-05

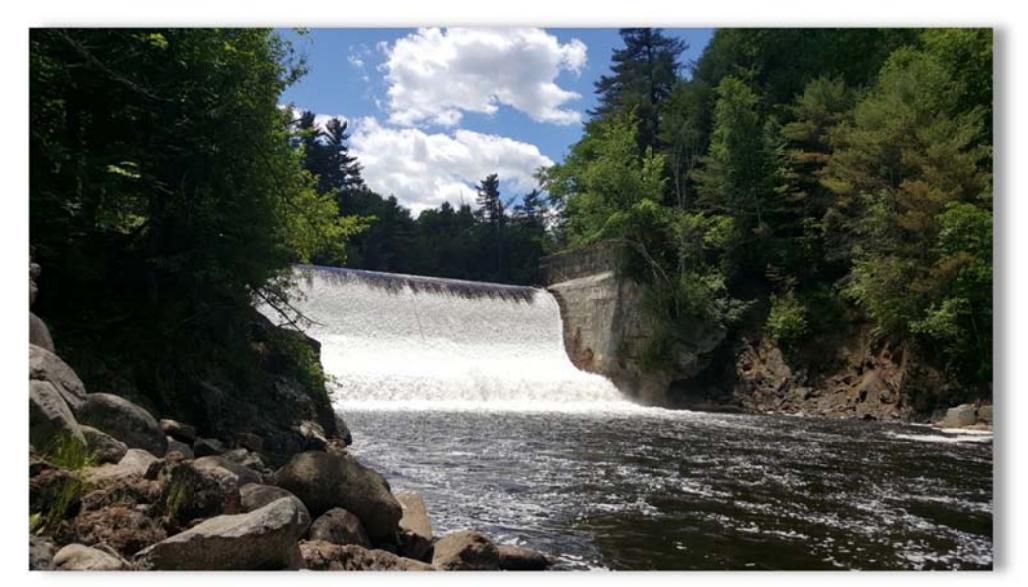
Figure 2-3: Rome Dam Spillway Facing Upstream (MMI, 2016)

MMI visited the dam on September 22, 2015, June 17, 2016, and August 30, 2016. Observations during site visits confirmed the deficiencies noted in prior inspections. Also noted was seepage undermining and outflanking both abutments on the downstream side of the spillway. Undermining is severe on river left where the penstock used to be located (Figure 2-3).

Spalling concrete was observed on the spillway and abutments. Stone was dislocated from the upstream corners of the stone masonry portions of both abutments.

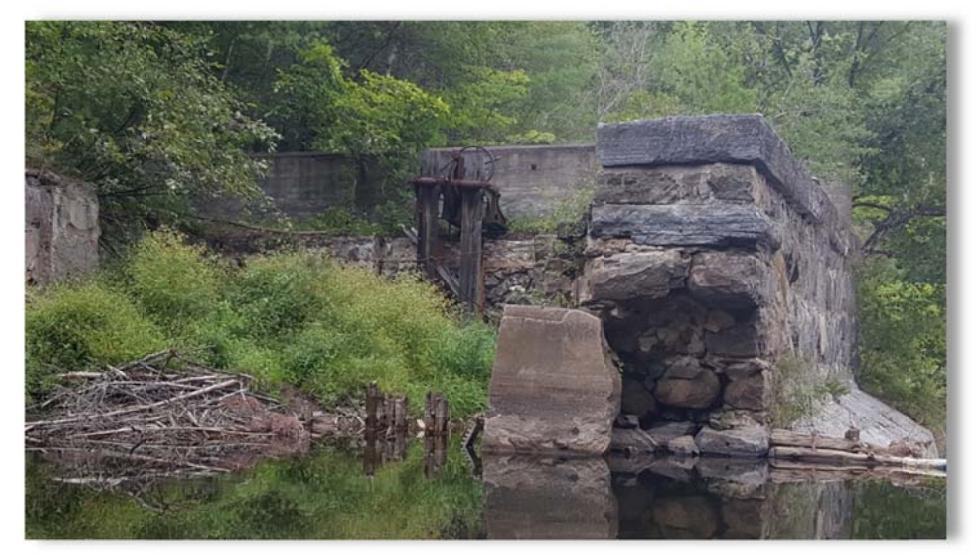
Figure 2-4: Dislocated Stone Masonry on Left Abutment (MMI, 2016)

The inlet works are nonoperational, uncontrolled, and filled with sediment and debris. Vortices in the standing water at the inlet works and seepage downstream indicated uncontrolled flow through former intakes that pose a failure hazard. Outlet works were also nonoperational and uncontrolled with significant seepage in the areas of the dislocated penstocks (Figures 2-4 and 2-5).

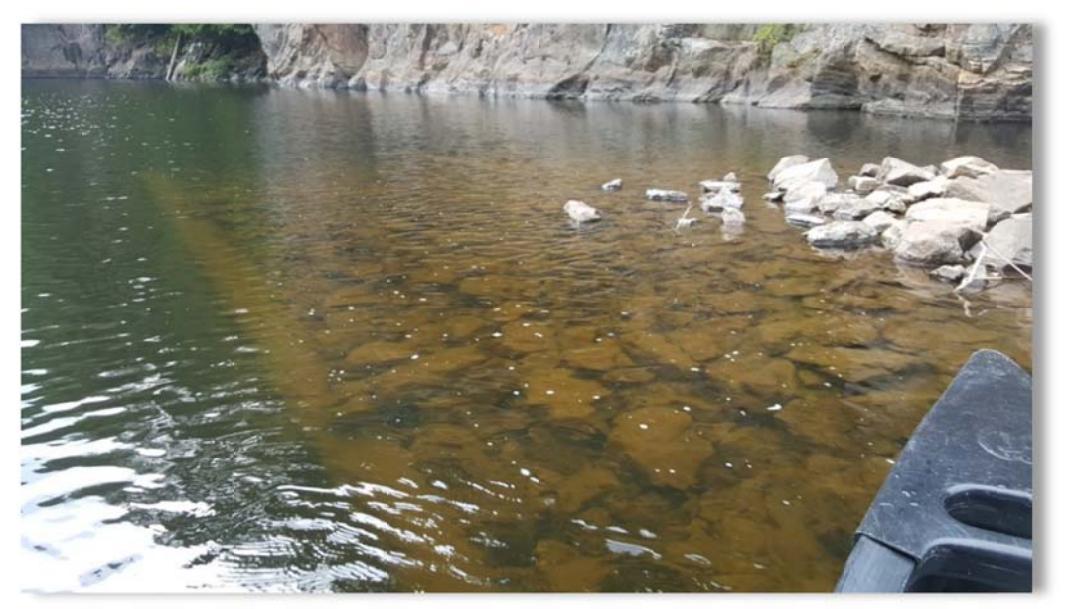
Figure 2-6: Submerged Timber Crib and Stone Structure (MMI, 2016)

Three timber crib structures filled with stone were located in the impoundment upstream of the dam (Figure 2-6). They are roughly 20 feet wide, 30 feet long, and up to 20 feet tall. The age and purpose of these structures is unknown, but based on similar structures found at other dam sites in the region, they appear to be piers used to anchor log booms designed to catch and trap the annual log load. These structures may be hazardous if the dam is removed and should be demolished.

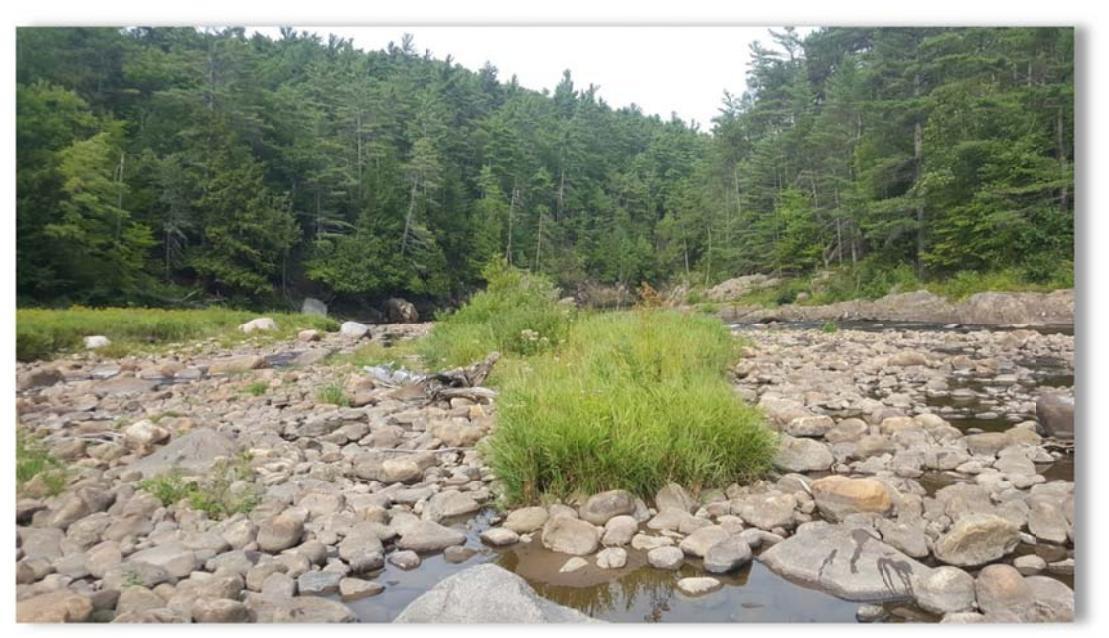
Figure 3-2: Aggradation Approaching the Impoundment (MMI, 2016)

The level of aggradation increases approaching the upstream end of the impoundment in the bedrock gorge (Figure 3-2). A delta exists for nearly 700 feet that consists of a wide cobble bed, multiple flow paths, and an overwidened channel. The sediment is held back due to a reduction of width between the channel and the beginning of the gorge where the bankfull channel width drops from approximately 160 feet to 70 feet (Figure 3-3). The pool has lower velocity and less sediment transport capacity, and water also flows directly into the bedrock wall on river left further reducing sediment transport.

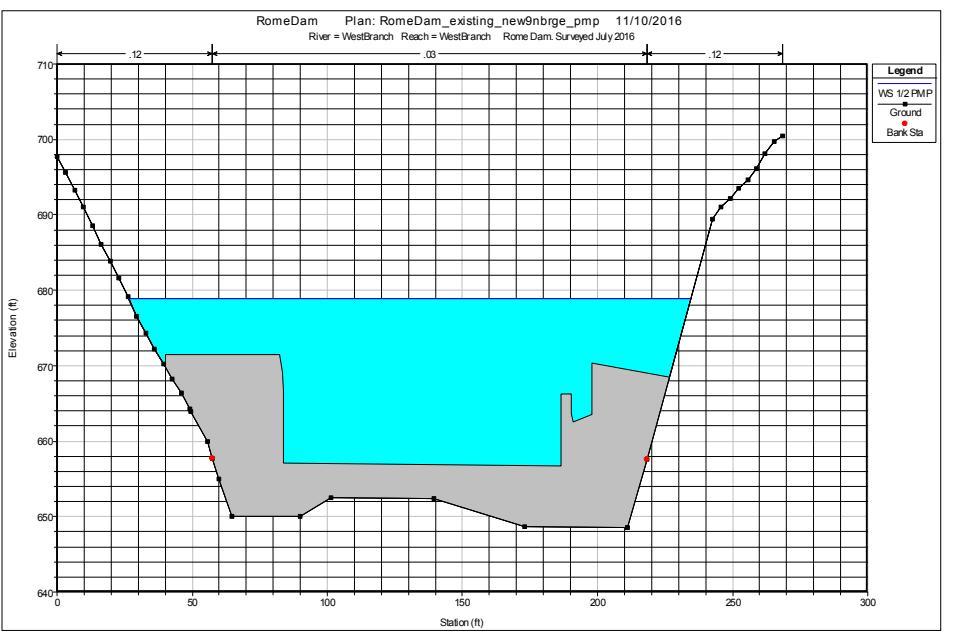
Figure 8-1: Model Cross Section of Rome Dam Showing Inadequate Spillway Capacity

A small, Class C dam is required to have adequate spillway capacity to pass 50 percent of the PMF with a minimum of 1 foot of additional space between the design water surface and the top of dam (i.e., freeboard). The hydraulic modeling results indicate that the dam is overtopped by approximately 8.5 feet during the ½ PMF (Figure 8-1) indicating that the dam's spillway does not meet NYS capacity requirements for a Class C dam.

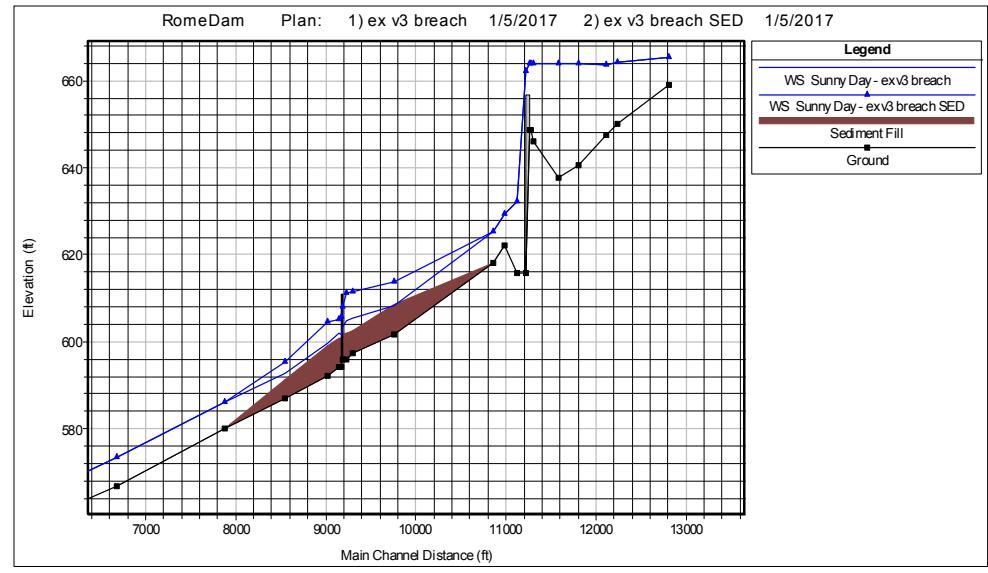
Figure 8-3: Profile with Sediment Filling Channel Near Robison Bridge and Increased Flood Levels during the "Sunny Day" Breach

The breach analysis with an initial sediment release that fills the channel near Robison Bridge leads to increased flood levels (Figure 8-3). Sediment deposition increases flooding to properties along Church Lane and Ausable Drive during the "Sunny Day" and "Stormy Day" dam failure scenarios (see Appendix J, Sheets 7, 8, and 9). Increased channel migration is anticipated with this sediment release, and as a result, the road embankments and homes in this area would likely be damaged by erosion.

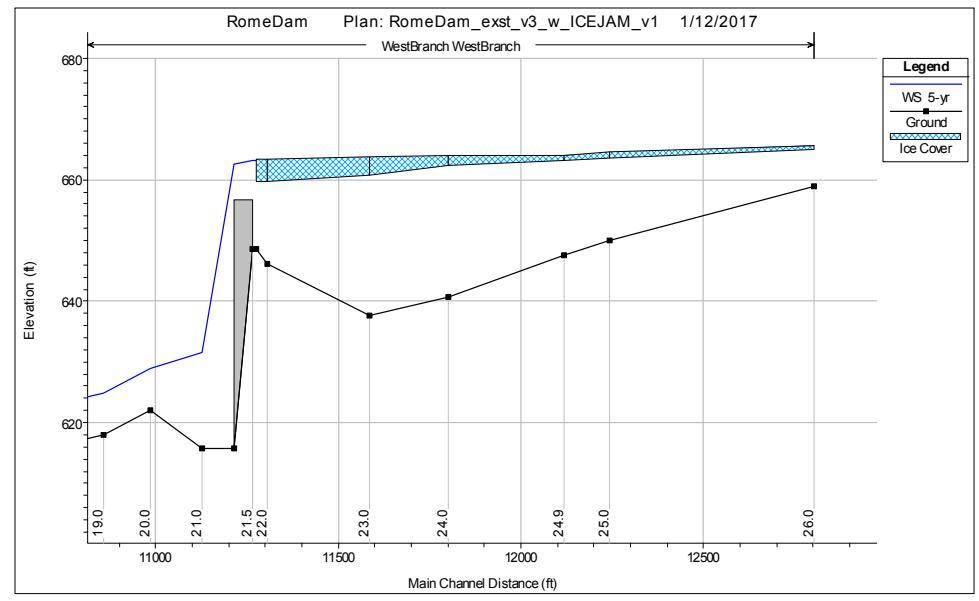
Figure 11-1: Ice Jamming at the Rome Dam during the 5-year Flood

The ice jam is approximately 4 feet thick at the dam during the 5-year flood (Figure 11-1). The modeling results show that the largest accumulation of ice at the Robison Bridge occurs during normal flow conditions with a thickness of approximately 1 foot. At the Main Street Bridge, the modeling results indicate that approximately 3.5 feet of ice buildup occurs during a flood equal to roughly the 1-year event (~1,000 cfs). The ice jam is approximately 4.5 feet thick near the Grove Islands and East Branch confluence during normal flow conditions.
