Technical Brief Volume 2, Issue 1 | Mirror Lake 2021 Water Quality Update

Mirror Lake 2021 Water Quality Update

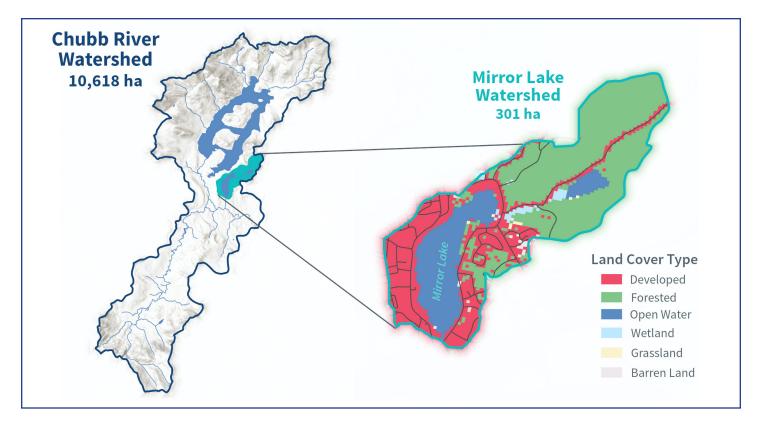
Figure 1. The Mirror Lake watershed (right) shown as part of the Chubb River watershed (left) with the distribution of land cover and road types within the Mirror Lake watershed. With 27% of land developed, there is a high proportion of impervious surfaces in the watershed. Stormwater runoff from roads, driveways, parking lots, rooftops, and other impervious surfaces collects and moves quickly, eroding soils and picking up sediment, debris, and pollutants as it makes its way to Mirror Lake. National Land Cover Database (NLCD) 2019.

Situated in western Essex County and bordered by the Town of North Elba and Village of Lake Placid, Mirror Lake (Figure 1) has a surface area of 50 hectares (124 acres) and watershed area of 301 hectares (741 acres). Of the total watershed area, 51% is forest, 27% is developed, 20% is surface water, and 2% is wetland (Wiltse et al. 2019). Much of this developed land area in the Mirror Lake watershed is covered by impervious surfaces, which do not allow fluids to pass. Indeed, Mirror Lake has over twice the percentage of developed land compared to any other lake studied in the Adirondack Lake Assessment Program (Laxson et al. 2016). This makes Mirror Lake one of the most developed lakes in the Adirondack Park. The headwaters of the watershed, draining from the ridge between Mt. Whitney and Cobble Hill, create Echo Lake which sits 1.5 km (0.9 miles) east of Mirror Lake. A small brook trout stream travels from Echo Lake, under Mirror Lake Drive through a small underground pipe into the north bay of Mirror Lake. This upstream portion of the watershed is mostly forested. Downstream, in the areas surrounding Mirror Lake, much of the land is developed (Figure 1). The lake drains to the south, through another underground pipe, into the Chubb River which flows into the West Branch Ausable River.
