Rome Dam Engineering Study (NY ID #219-1082)

Jay, New York February 28, 2017

MMI #5810-01-05

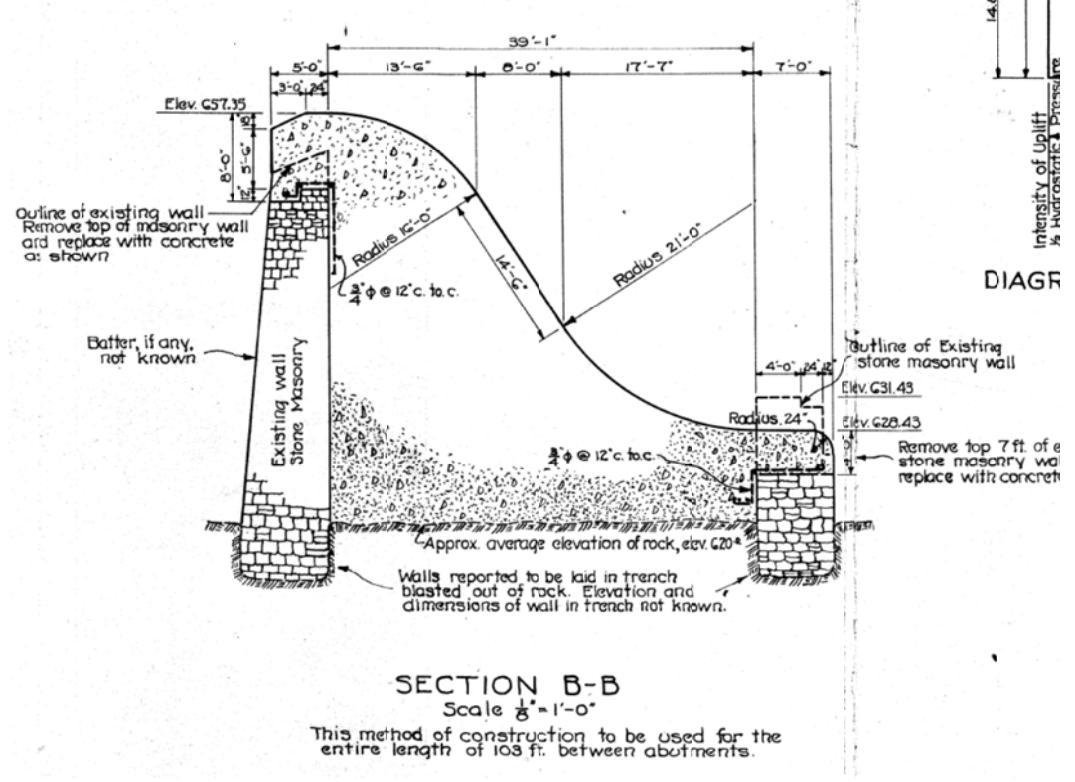
Figure 2-2: Dam Cross Section from the 1936 Repair Plans Prepared for J. and J. Rogers Company by Robert E. Horton Consulting Engineers

The Rome Dam was damaged in 1936 after the failure of an upstream dam where timber and debris floating downstream broke off timber flashboards and carried away the apron and stone fill for about 2/3 the length of the dam. The dam's spillway was rebuilt as a concrete ogee structure (Figure 2-2). Plans from the 1936 repairs indicate that the dam is founded on granite bedrock. The dam's use for mill power ceased in 1973. The dam has since been out of service and unmaintained.

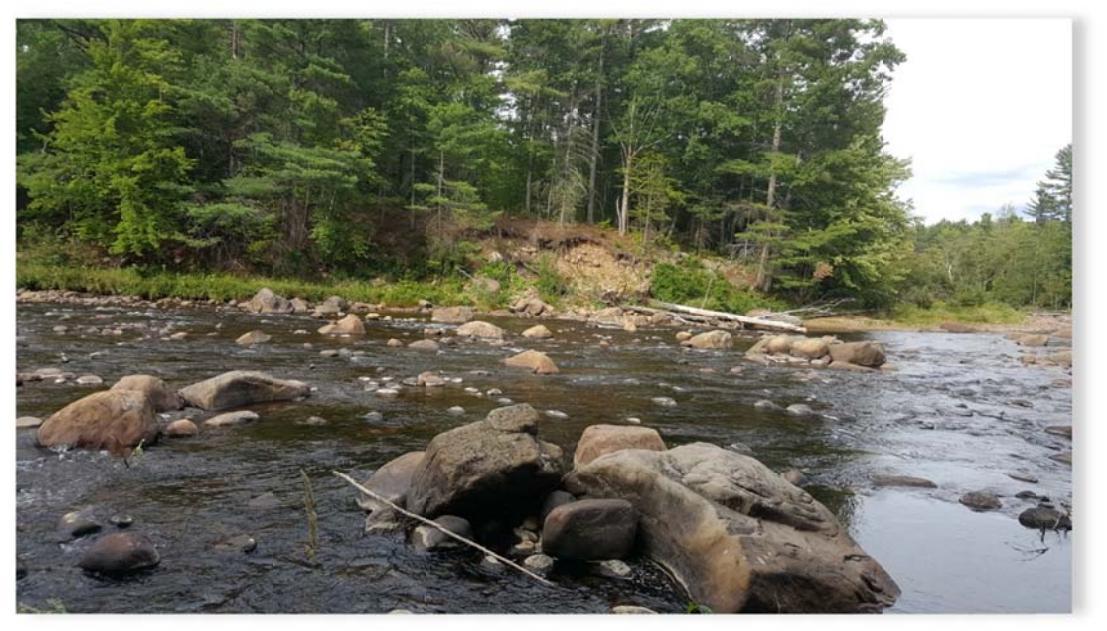
Figure 3-1: Upstream Riffle-Pool Channel (MMI, 2016)

The channel located 2,000 feet upstream of the dam has riffles and pools, is a singlethread channel, and is connected to its floodplain (Figure 3-1). The channel appears to be able to spill onto its broad floodplain during a modeled 5- to 10-year flood. The channel appears to be moving large boulders during floods that are now perched on top of sediment bars. The channel is wide and possibly overwidened due to historical aggradation that may have resulted from channel smoothing and clearing for log drives

or alteration of upstream hydrology and sediment load. The bed features often are covered by excess sediment buildup.

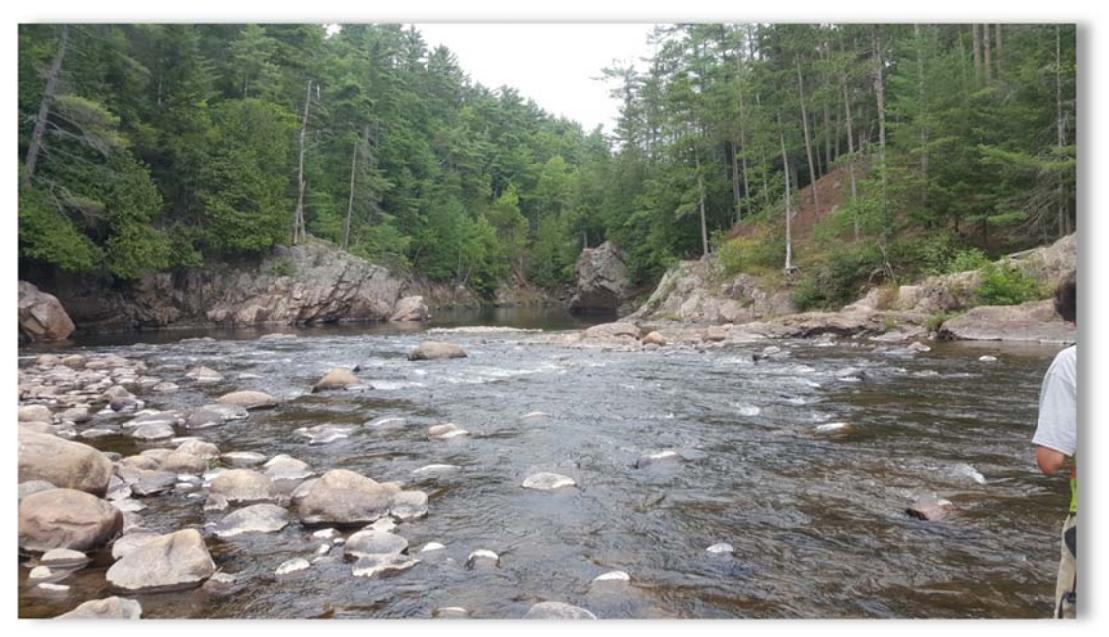
Figure 3-3: Reduction in Channel Width Heading into the Impoundment (MMI, 2016)

The level of aggradation increases approaching the upstream end of the impoundment in the bedrock gorge (Figure 3-2). A delta exists for nearly 700 feet that consists of a wide cobble bed, multiple flow paths, and an overwidened channel. The sediment is held back due to a reduction of width between the channel and the beginning of the gorge where the bankfull channel width drops from approximately 160 feet to 70 feet (Figure 3-3). The pool has lower velocity and less sediment transport capacity, and water also flows directly into the bedrock wall on river left further reducing sediment transport.

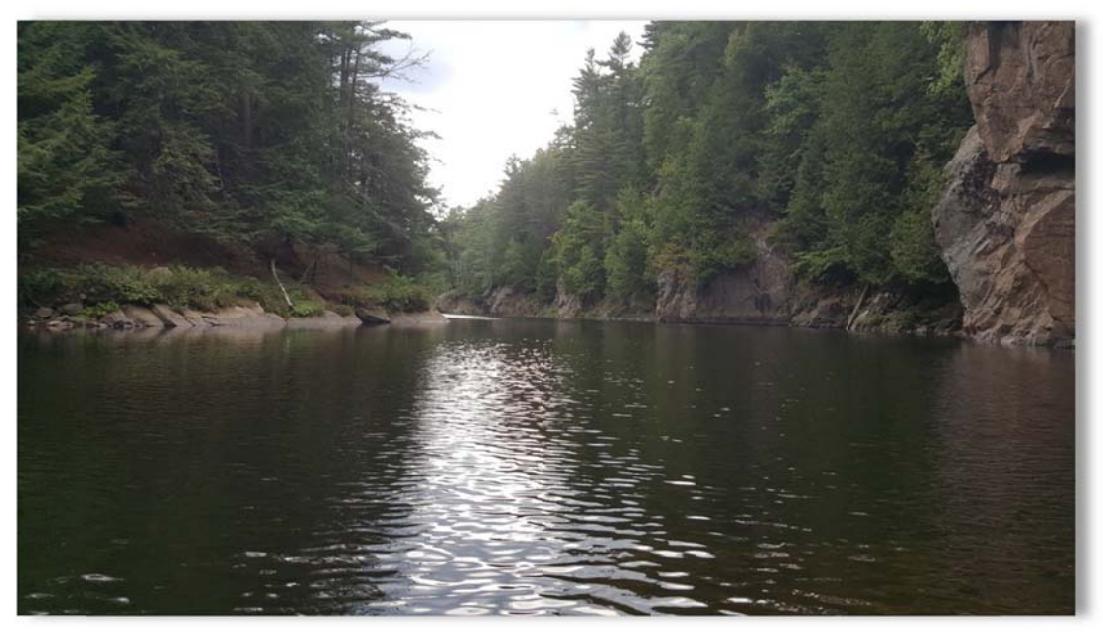
Figure 3-4: Bedrock Gorge Impoundment (MMI, 2016)

The impoundment is located in a narrow bedrock gorge that is partially filled with sediment (Figures 3-4 and 3-5). Probing shows that water depths vary moving down through the impoundment and range between 2 and 25 feet (Table 3-2). The thickness of deposited sediment also varies in the impoundment. The sediment is coarse moving into the impoundment from the upstream channel and gets finer moving downstream. Initial probing by MMI revealed cobble in the upstream end of the impoundment, gravel

and coarse sand in the middle of the impoundment, and sand and silt in the downstream end of the impoundment near the dam.

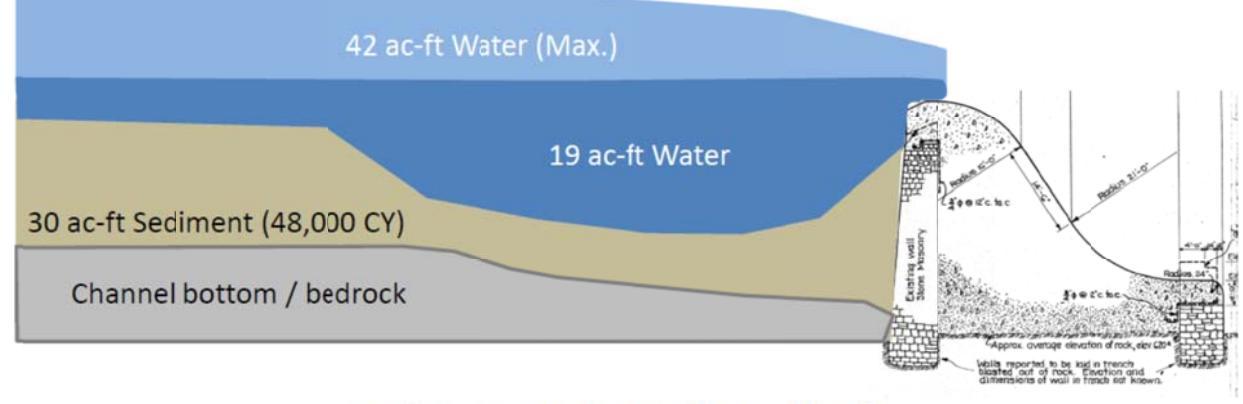
Figure 4-2: Estimated Storage of Sediment and Water at Rome Dam

indicate that approximately 30 acre-feet (48,000 cubic yards) of accumulated sediment is currently being stored behind the dam. Therefore, the volume of sediment and water combined is approximately 49 acre-feet at the spillway and approximately 91 acre-feet at the top of the dam (Figure 4-2).

- Storage capacity at spillway = 49 ac-ft
- Storage capacity at top of dam = 91 ac-ft

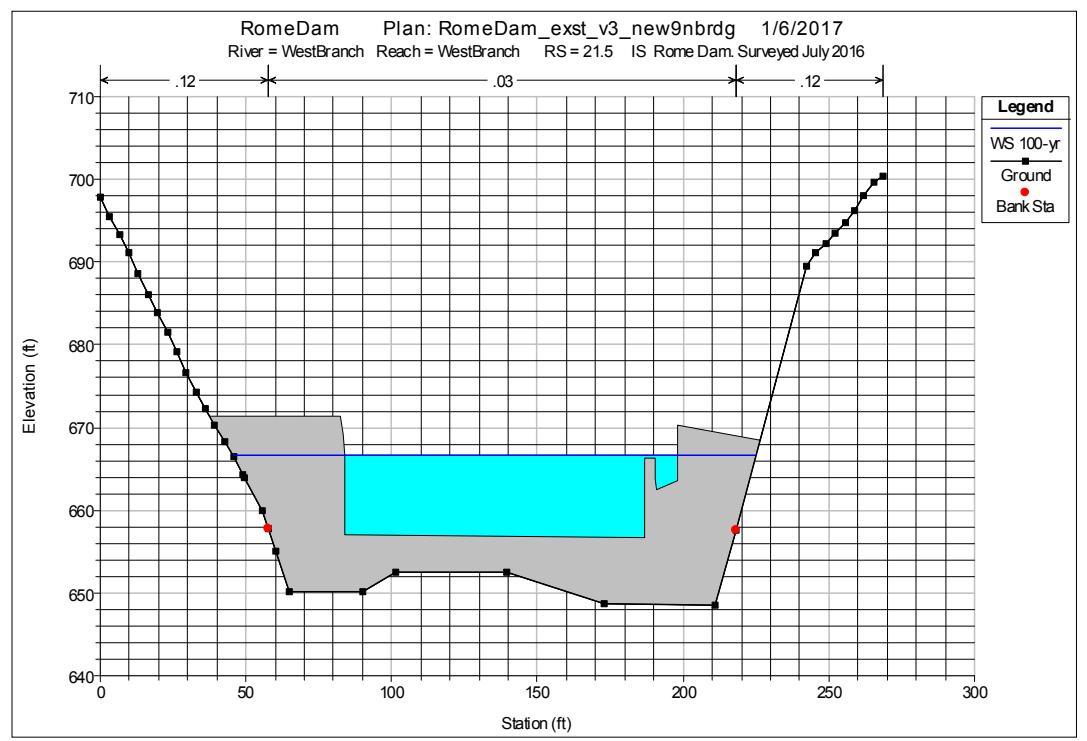
Figure 8-2: Model Cross Section of Rome Dam Showing Existing Spillway during 100-yr Flood

The spillway is capable of passing a 100-year flood with approximately 3.7 feet of freeboard (Figure 8-2).

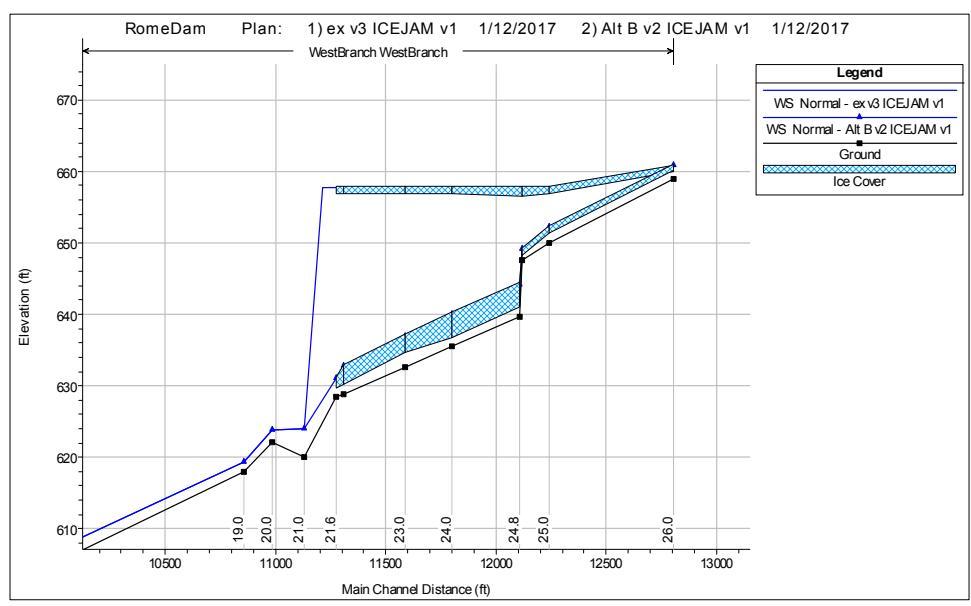
Figure 11-2: Ice Jamming at the Rome Dam with Full Removal during Normal Flow

Modeling results indicate that flood levels and ice-jam thicknesses are reduced locally and within the impoundment with full removal of the dam during the 5-year flood where the ice jam thickness is reduced to approximately 1 foot. The modeling results indicate that ice jam thickness will increase to approximately 3.5 feet after full removal under normal flow conditions (Figure 11-2). However, removal of the dam and lowering the typical water surface elevation create more storage volume available for ice, which reduces water surface levels during ice-out floods.
