**Technical Brief** Volume 3, Issue 1 | A Plan for Restoring Stream Health

# A Plan for Restoring Stream Health

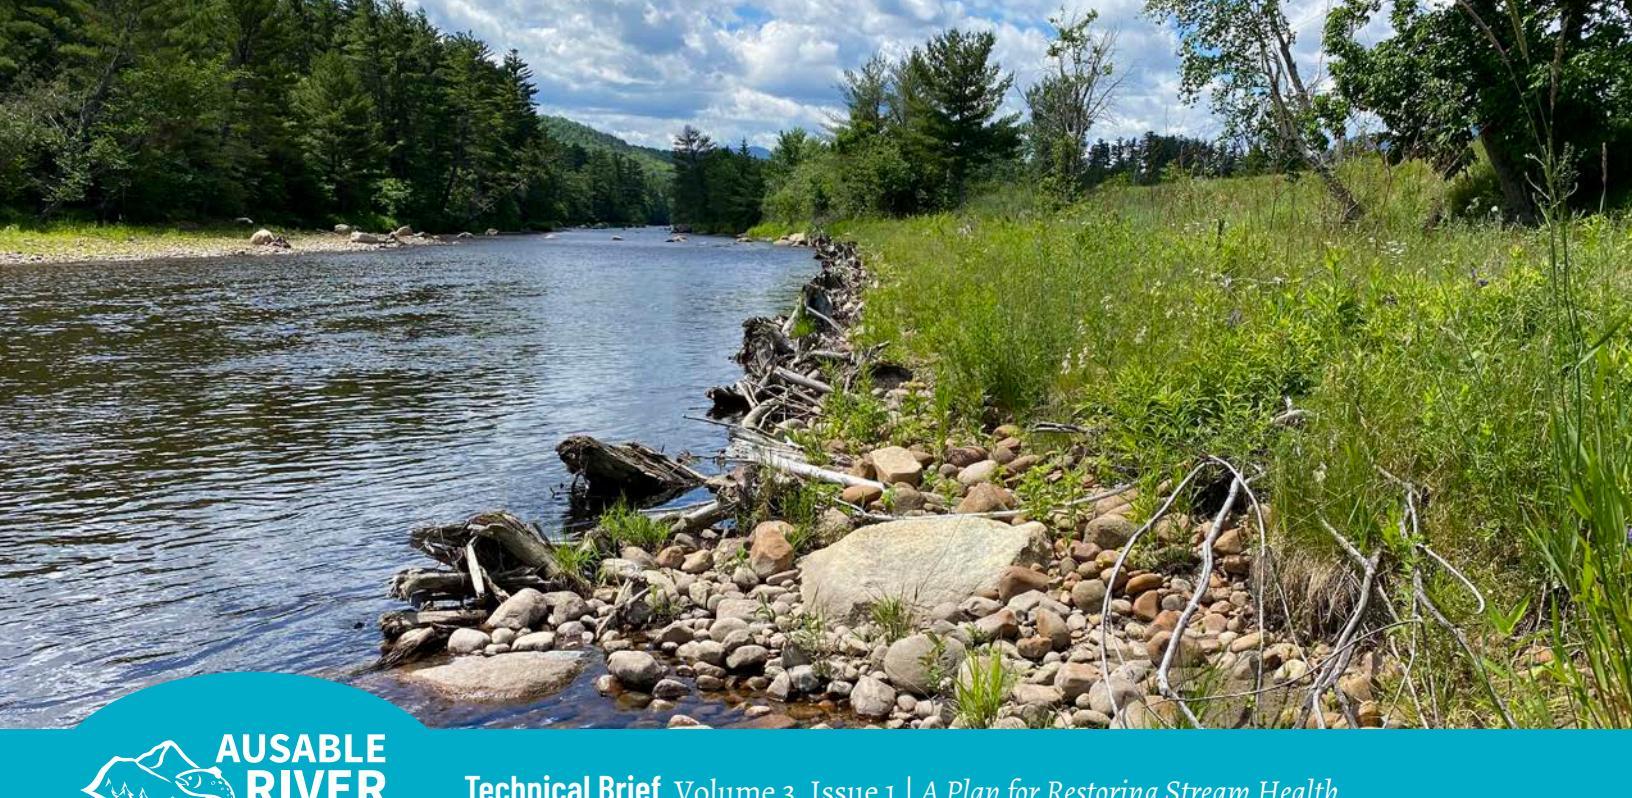
COVER IMAGE: Toe wood benches like the one pictured above are among the tools used in natural stream restoration. This 30-foot-deep bench sits just above normal low flows. It is constructed of 60- to 80-foot trees, 18-24 inches in girth, with their root wads intact. Each tree is laid horizontally, angled slightly downward and into the water flow with 10–15 feet between each root crown. The roots sit at the toe of the slope, hence the name. Natural materials—river sediment, wood, and coconut fiber fabric-are layered on top of the trees. The top is seeded with native plants so that, within a few years, the bench will be indistinguishable from other healthy banks. The bench narrows the channel and plays a vital role as water rises. In a typical spring flood, water will move up onto the bench, slowing its velocity and providing protection for the road. The toe wood is resilient, easily withstanding high flows and ice, providing habitat for fish, absorbing stream energy, and slowing flood water.

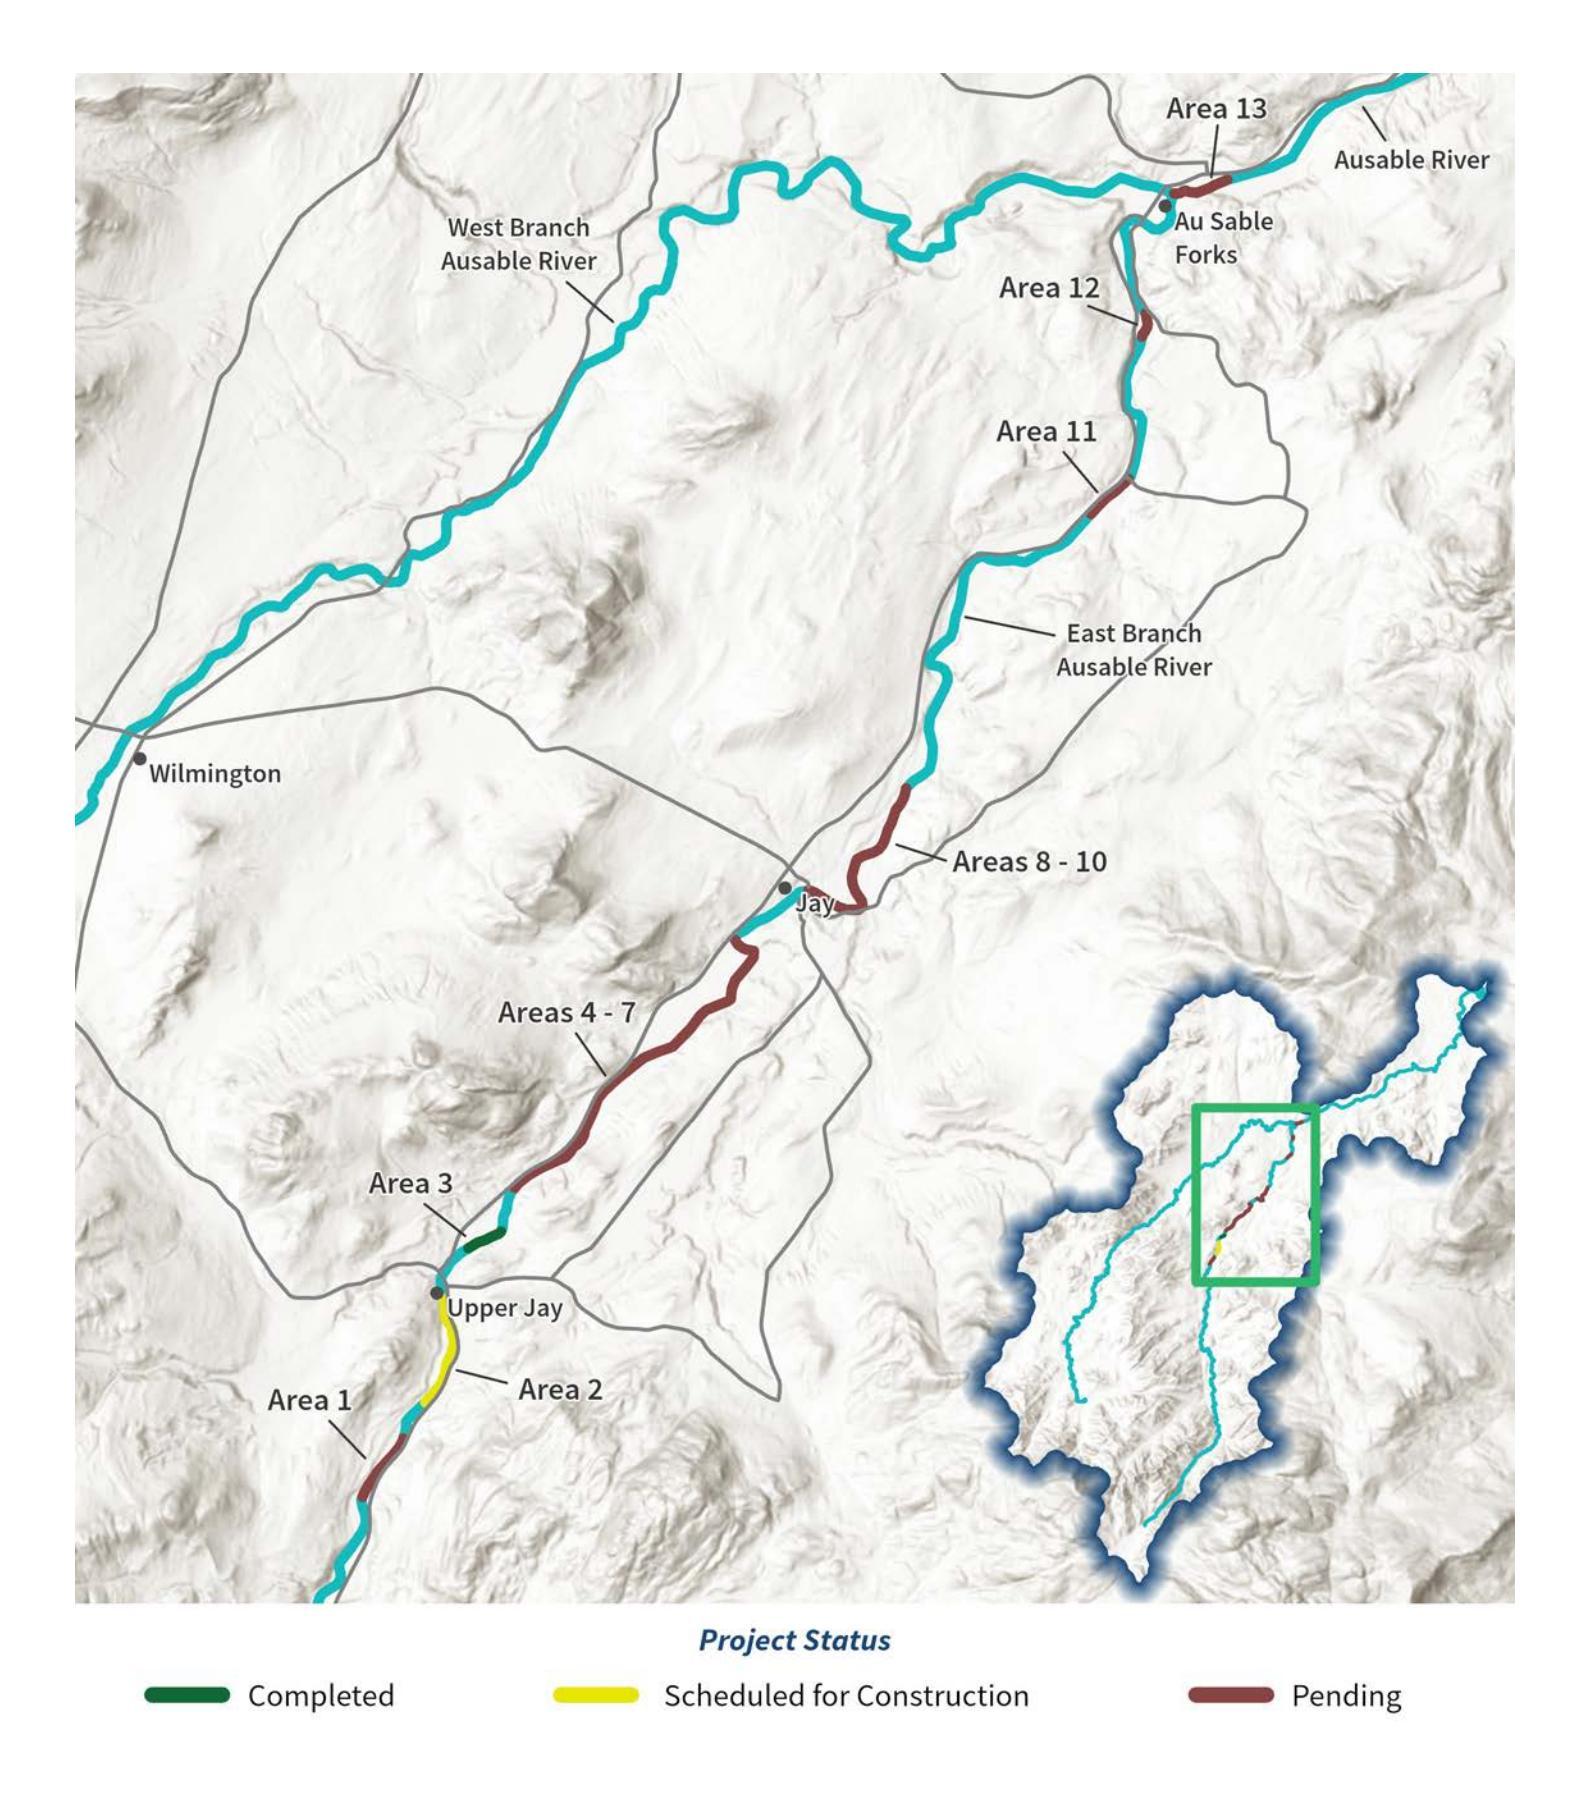
The East Branch Restoration Program identifies 13 sites in the Town of Jay in need of restoration to improve flood resilience, protect communities and infrastructure, and restore habitat for the food web that supports our native brook trout. AsRA has received funds to expand the restoration program through the Town of Keene in 2023–24.

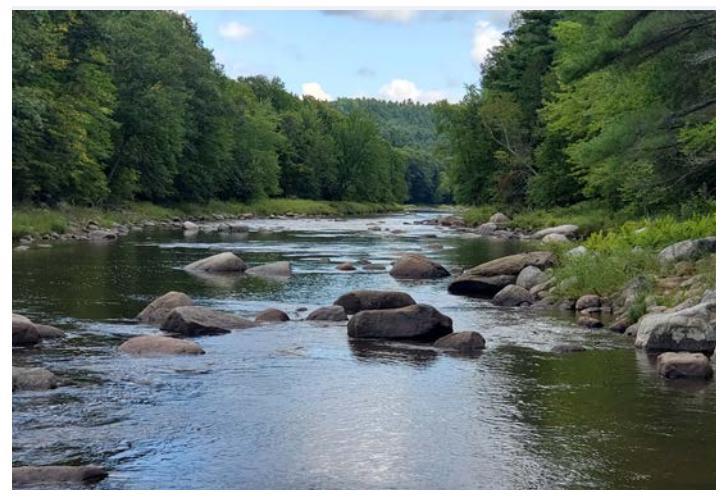
Healthy, stable sections of the East Branch, like this section of the river in the Town of Jay, serve as guides for our restoration designs. We strive to recreate what works on natural, functioning rivers to bring stability to areas that are out of balance.
