DAM BREACH INUNDATION MAP - 100-YR FAILURE	
ROME DAM ENGINEERING STUDY	
JAY, NEW YORK	
Map By: BMC	MM#: 5810-01
MXD: RD-DamBreach_sht1.mxd	1st Version: 2/16/2017
Revision:	Scale: 1 in = 400 ft
Figure 1A	
SOURCE(S): BING Maps - Aerials MJ Engineering & Land Surveying - Field Survey

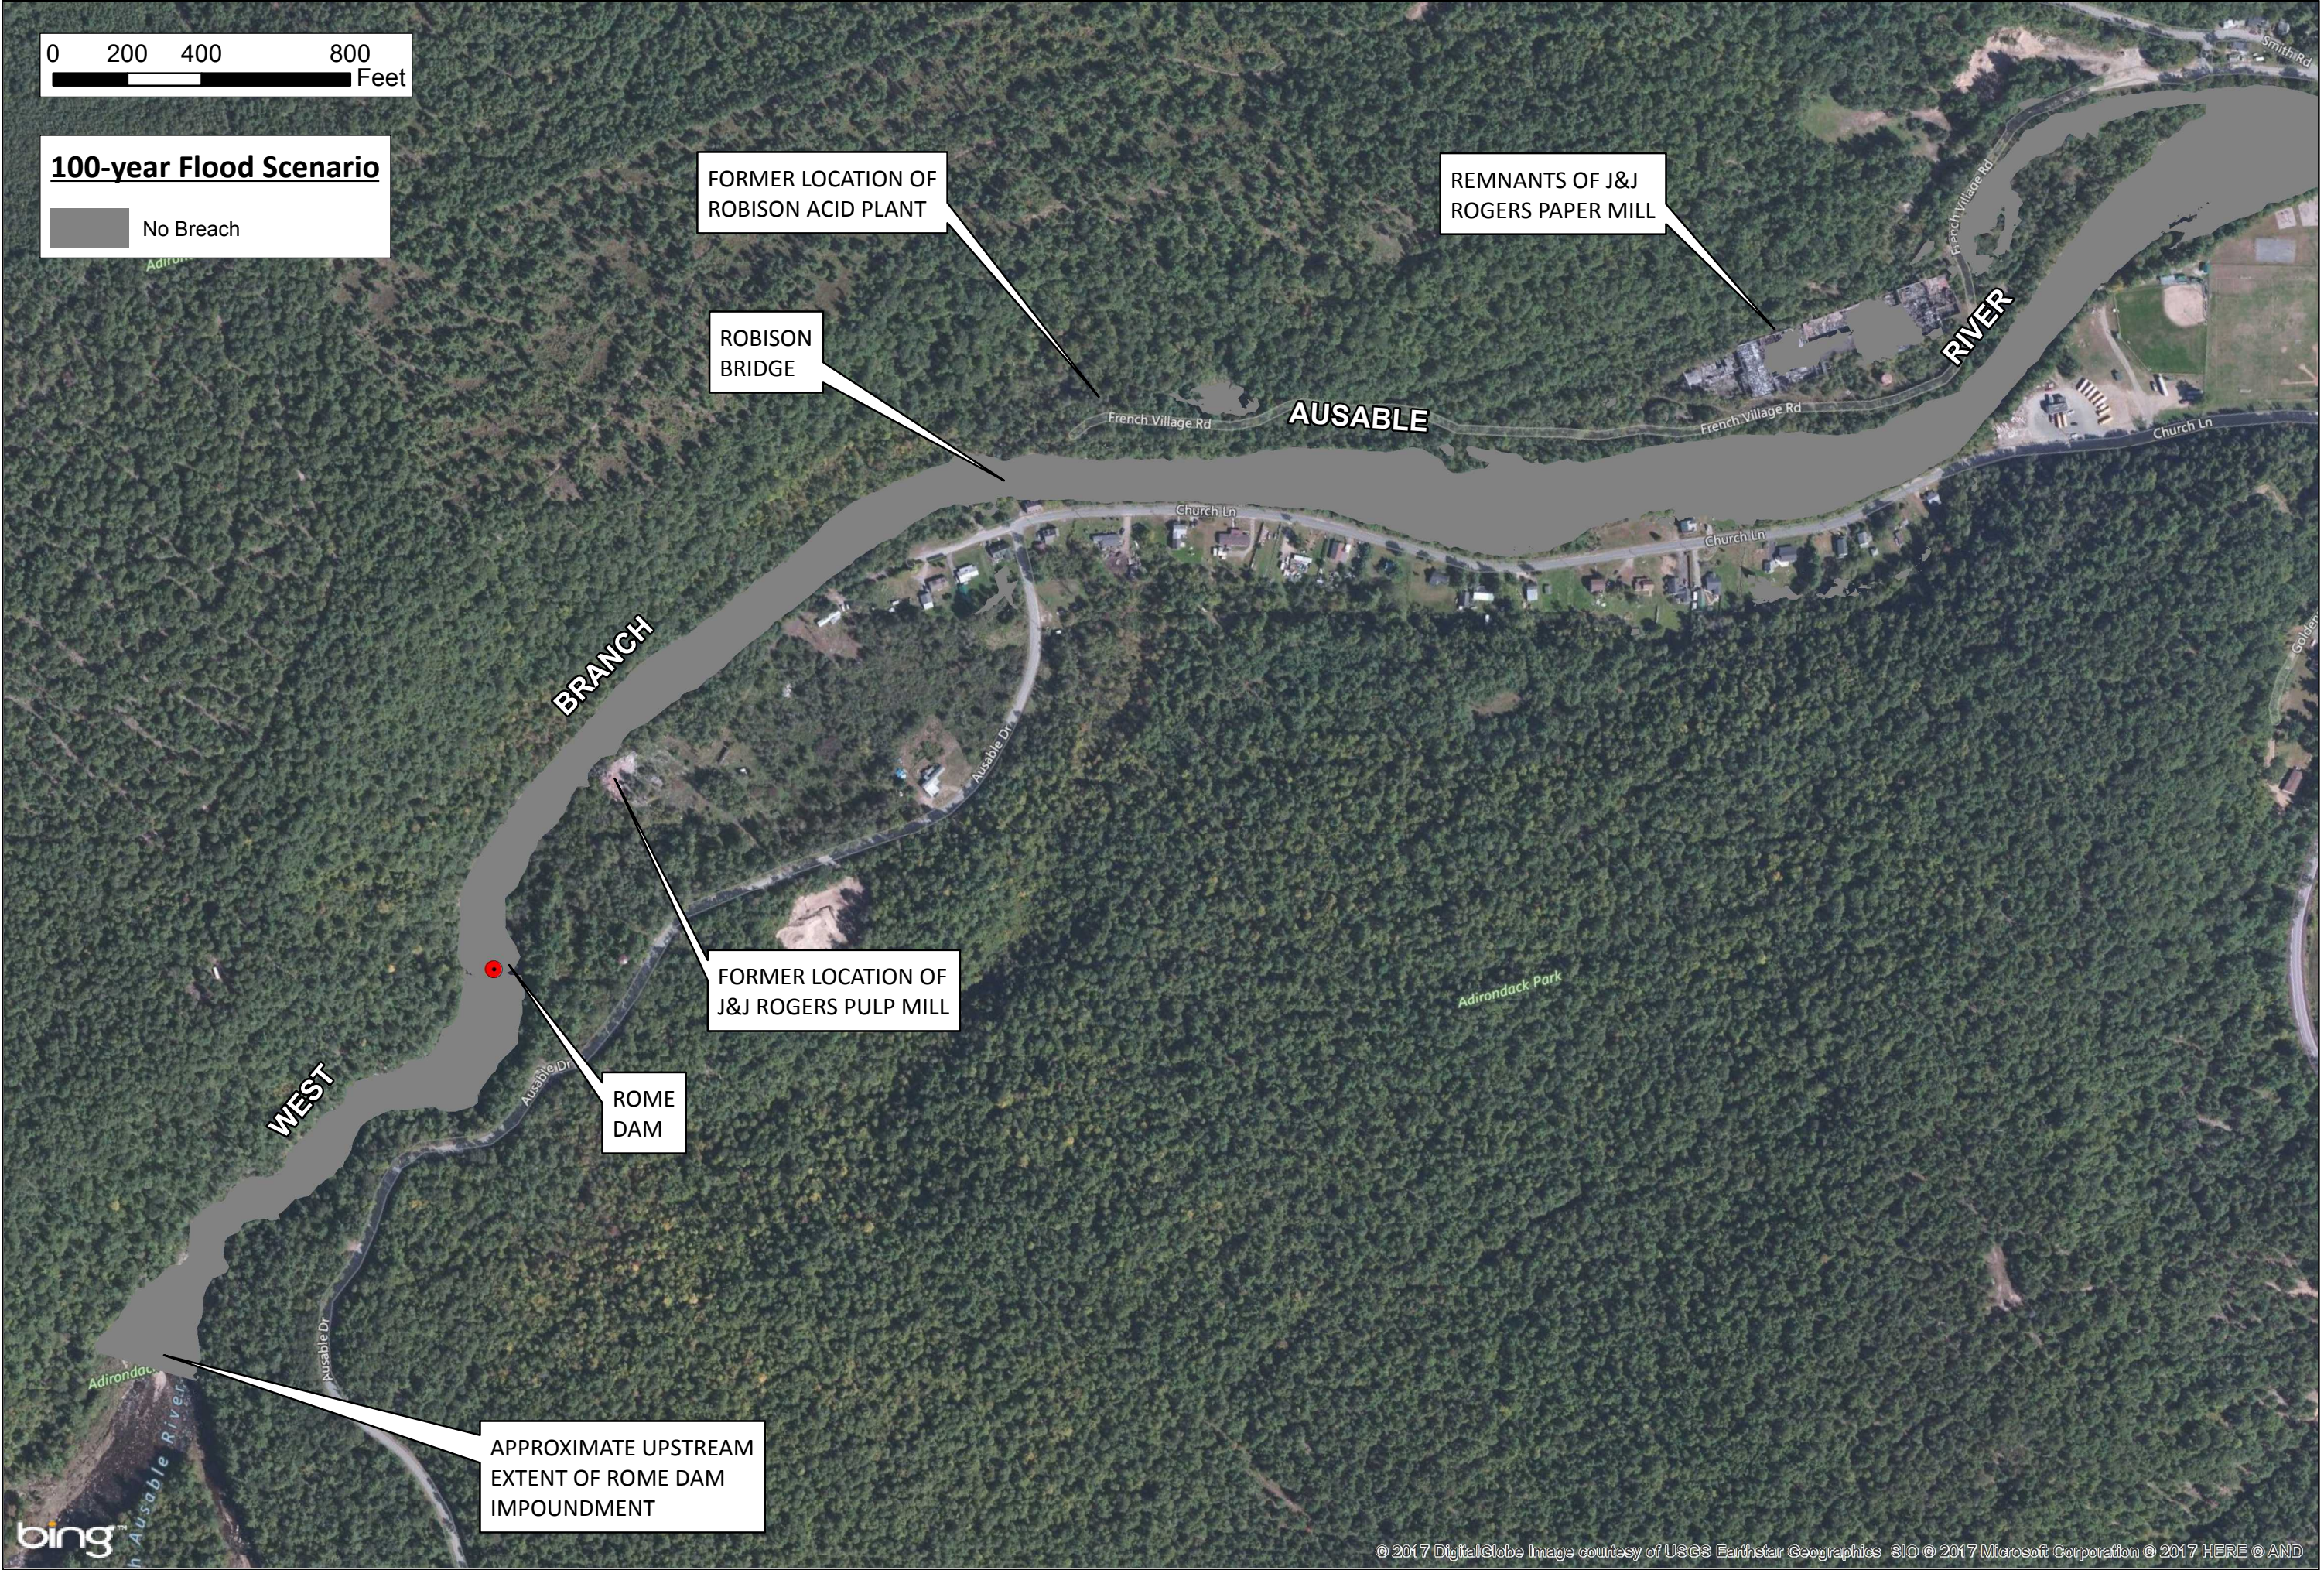
100-year Flood Scenario

No Breach

ROME DAM

APPROXIMATE UPSTREAM EXTENT OF ROME DAM IMPOUNDMENT
