| <b>DAM BREACH INUNDATION MAP - 100-YR FAILURE</b> | | |
| <b>ROME DAM ENGINEERING STUDY</b> | | |
| <b>JAY, NEW YORK</b> | | |

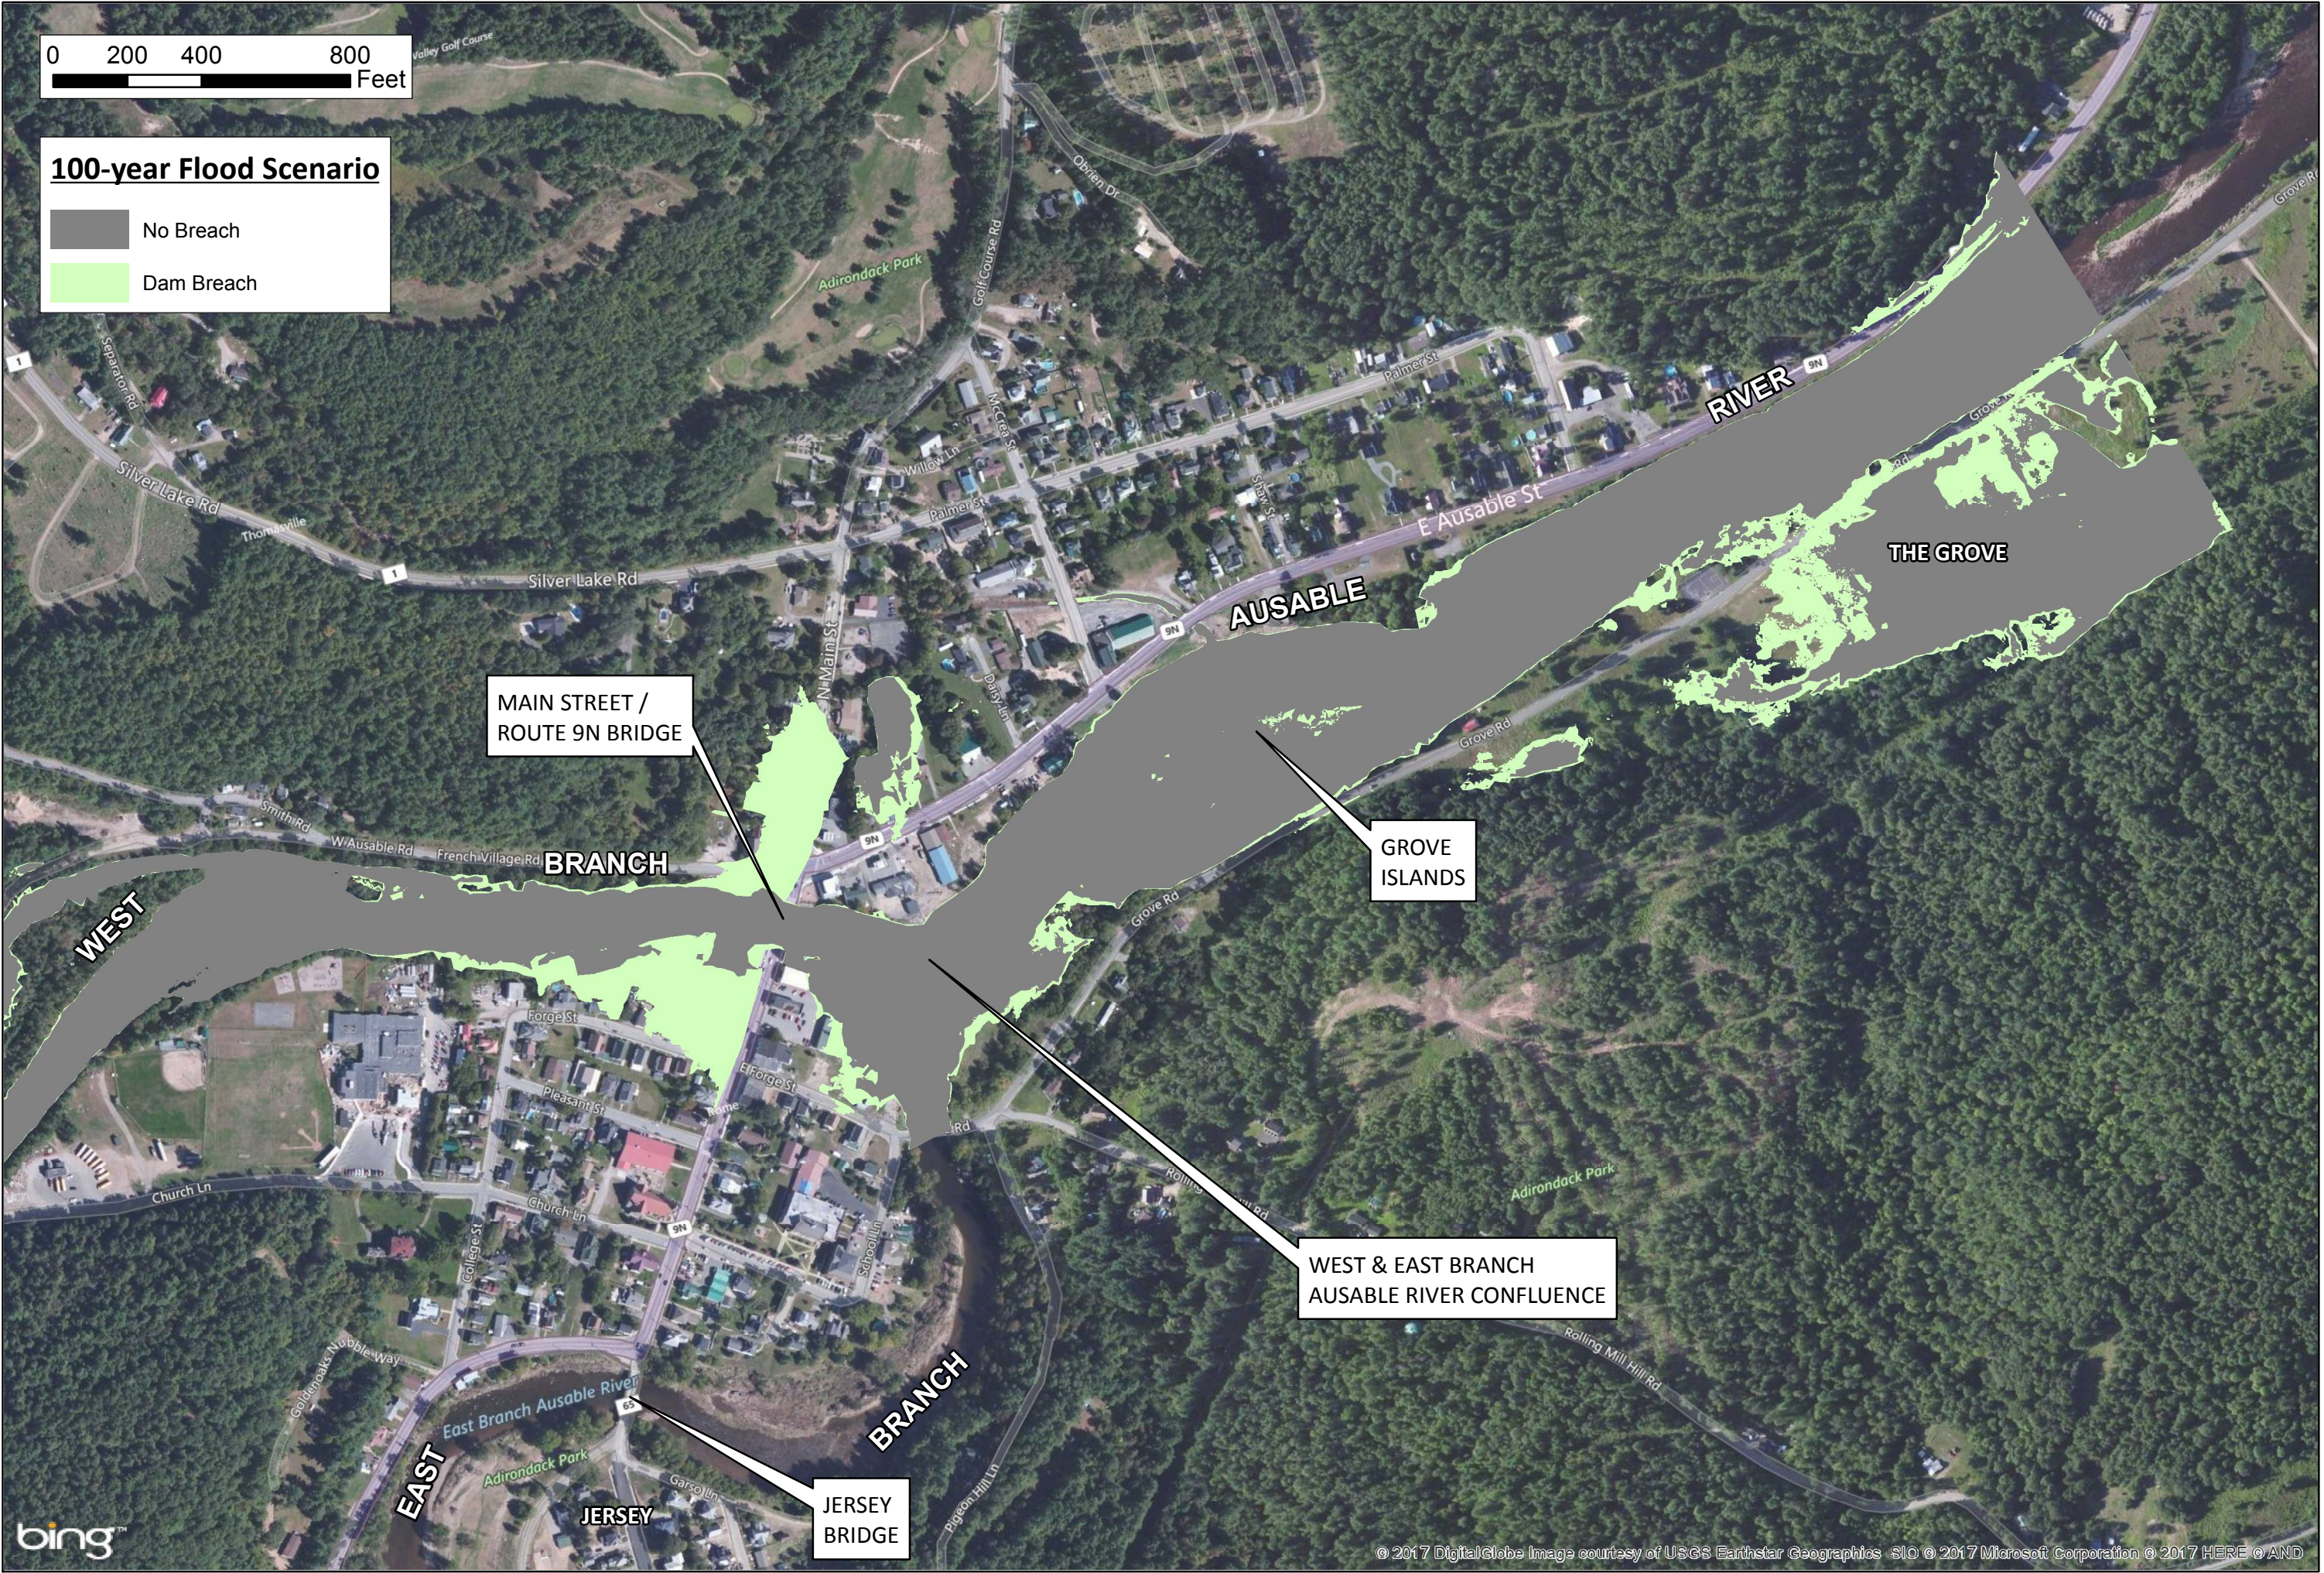
| <b>DAM BREACH INUNDATION MAP - 100-YR FAILURE</b> | | <b>Figure 2B</b> |

**100-year Flood Scenario**

- No Breach
- Dam Breach

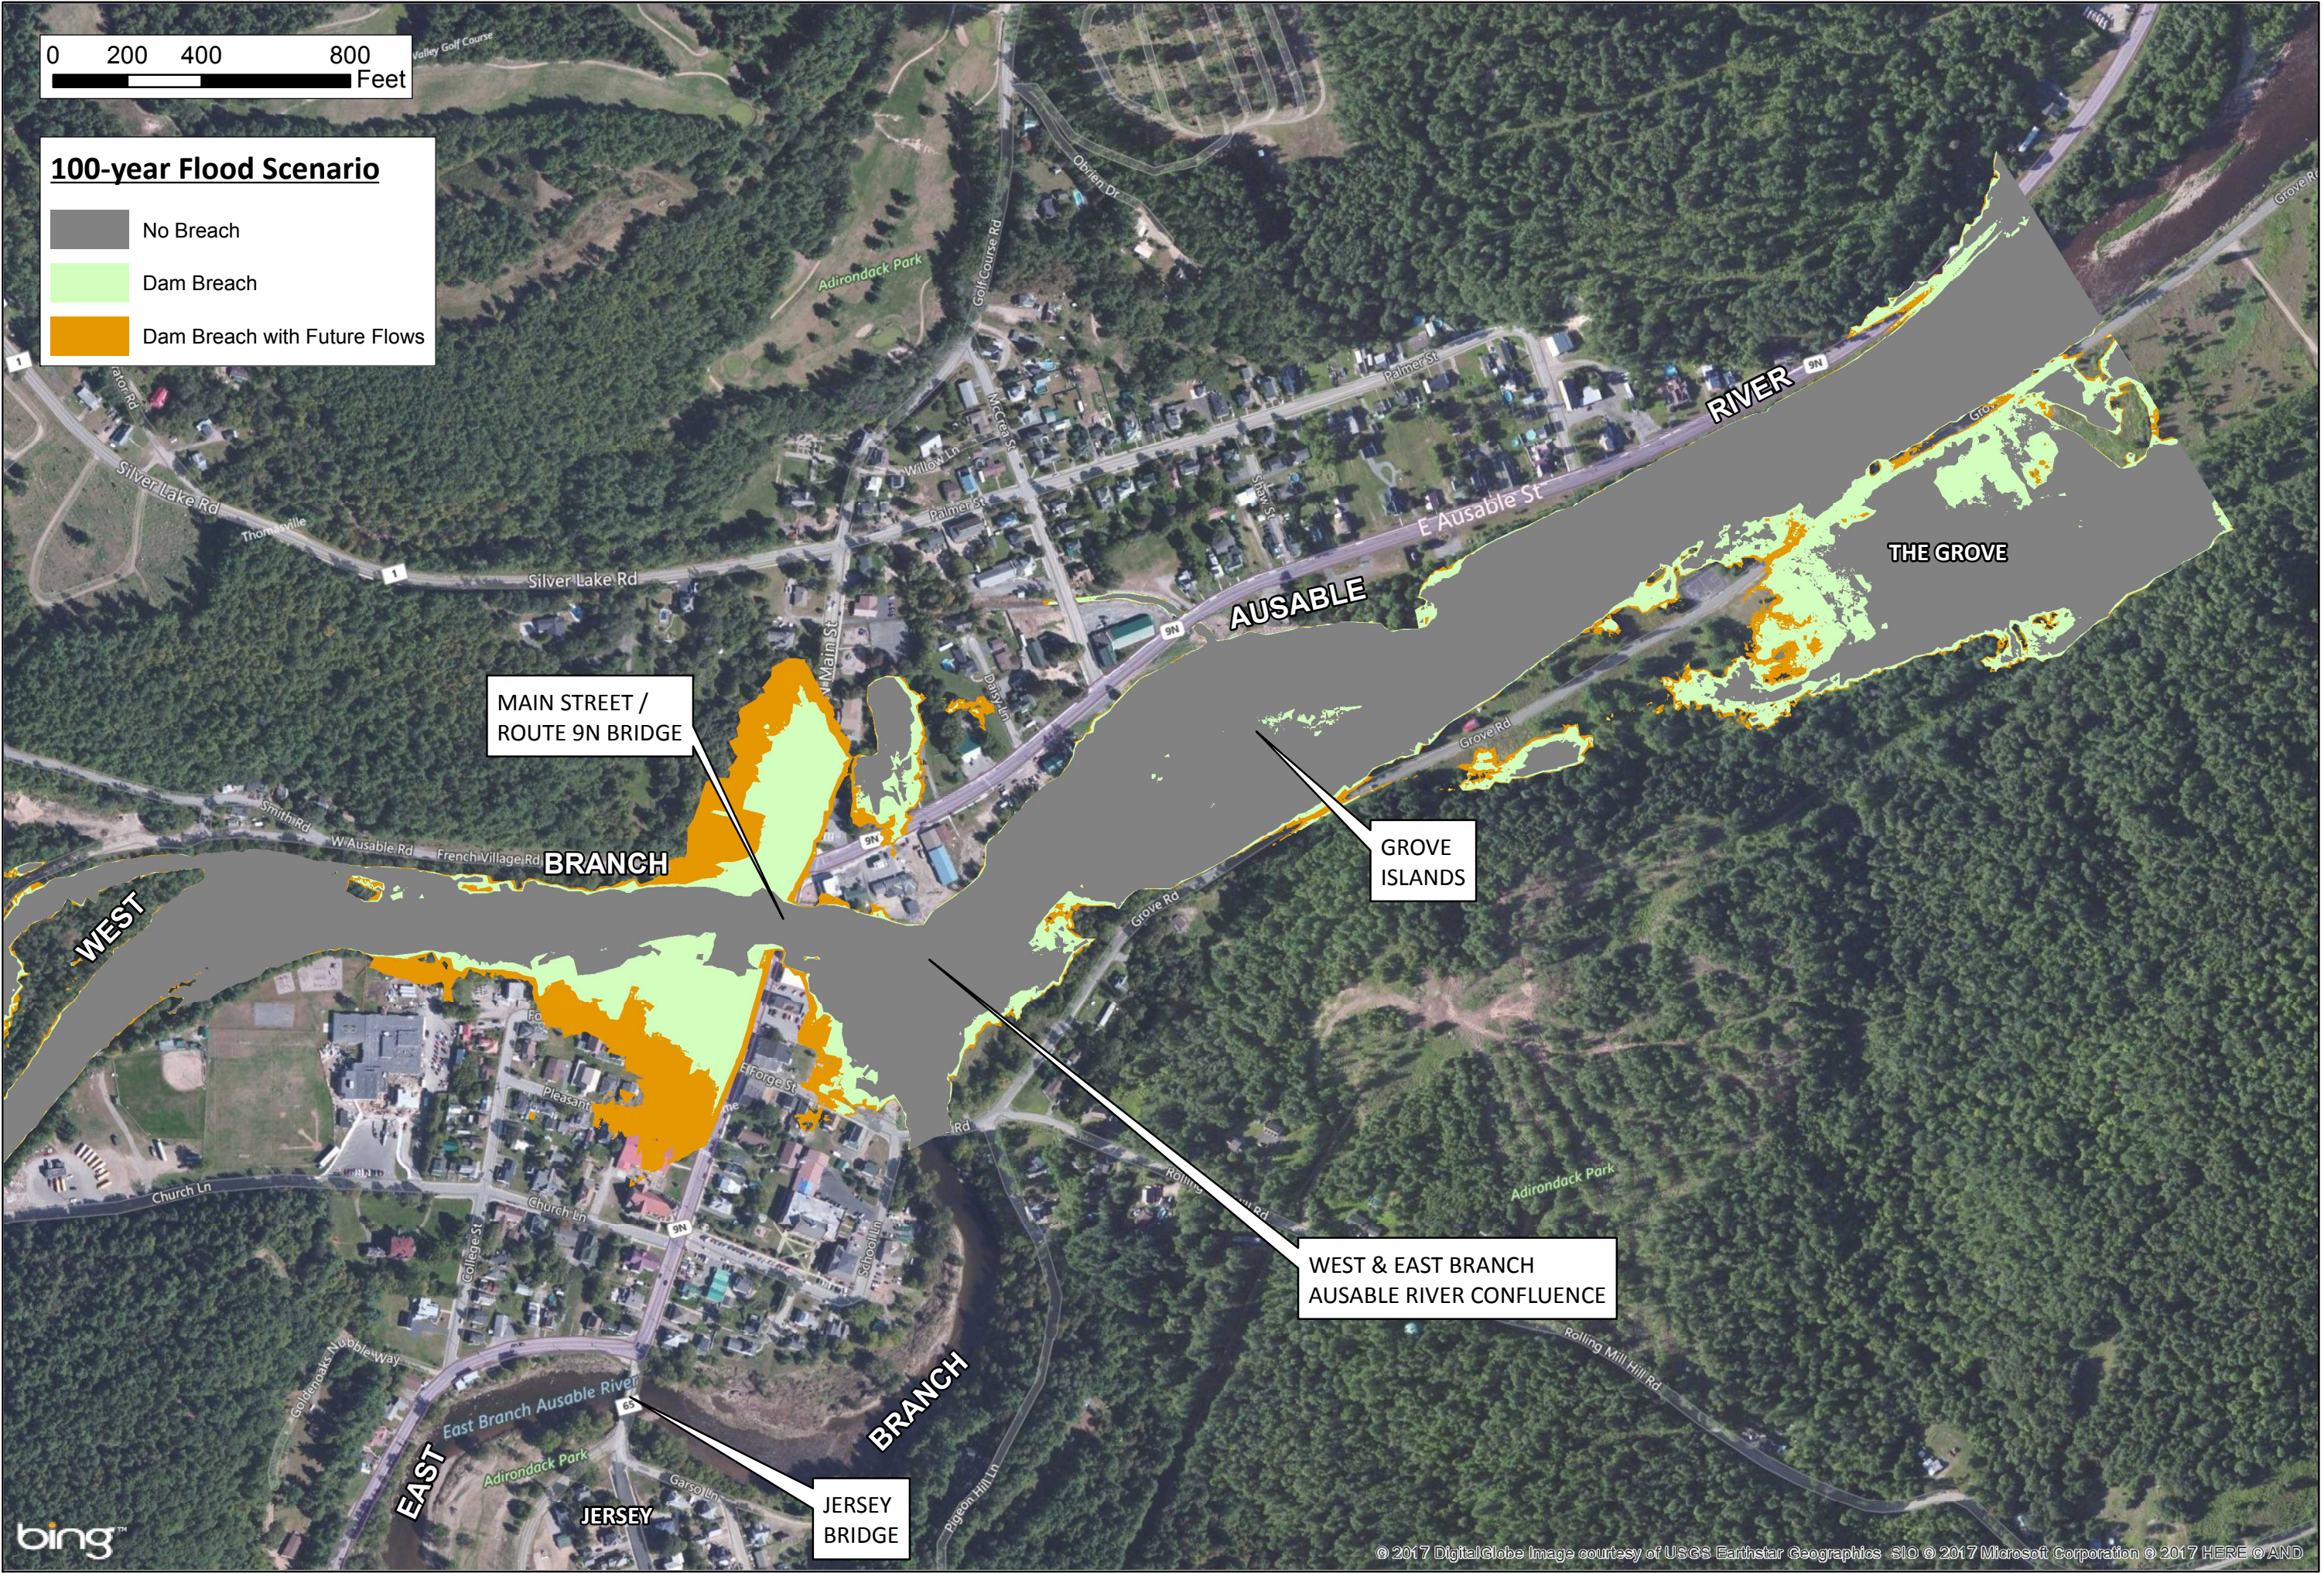
| <b>DAM BREACH INUNDATION MAP - 100-YR FAILURE</b> | | <b>Figure 3B</b> |

**100-year Flood Scenario**

- No Breach
- Dam Breach
- Dam Breach with Future Flows

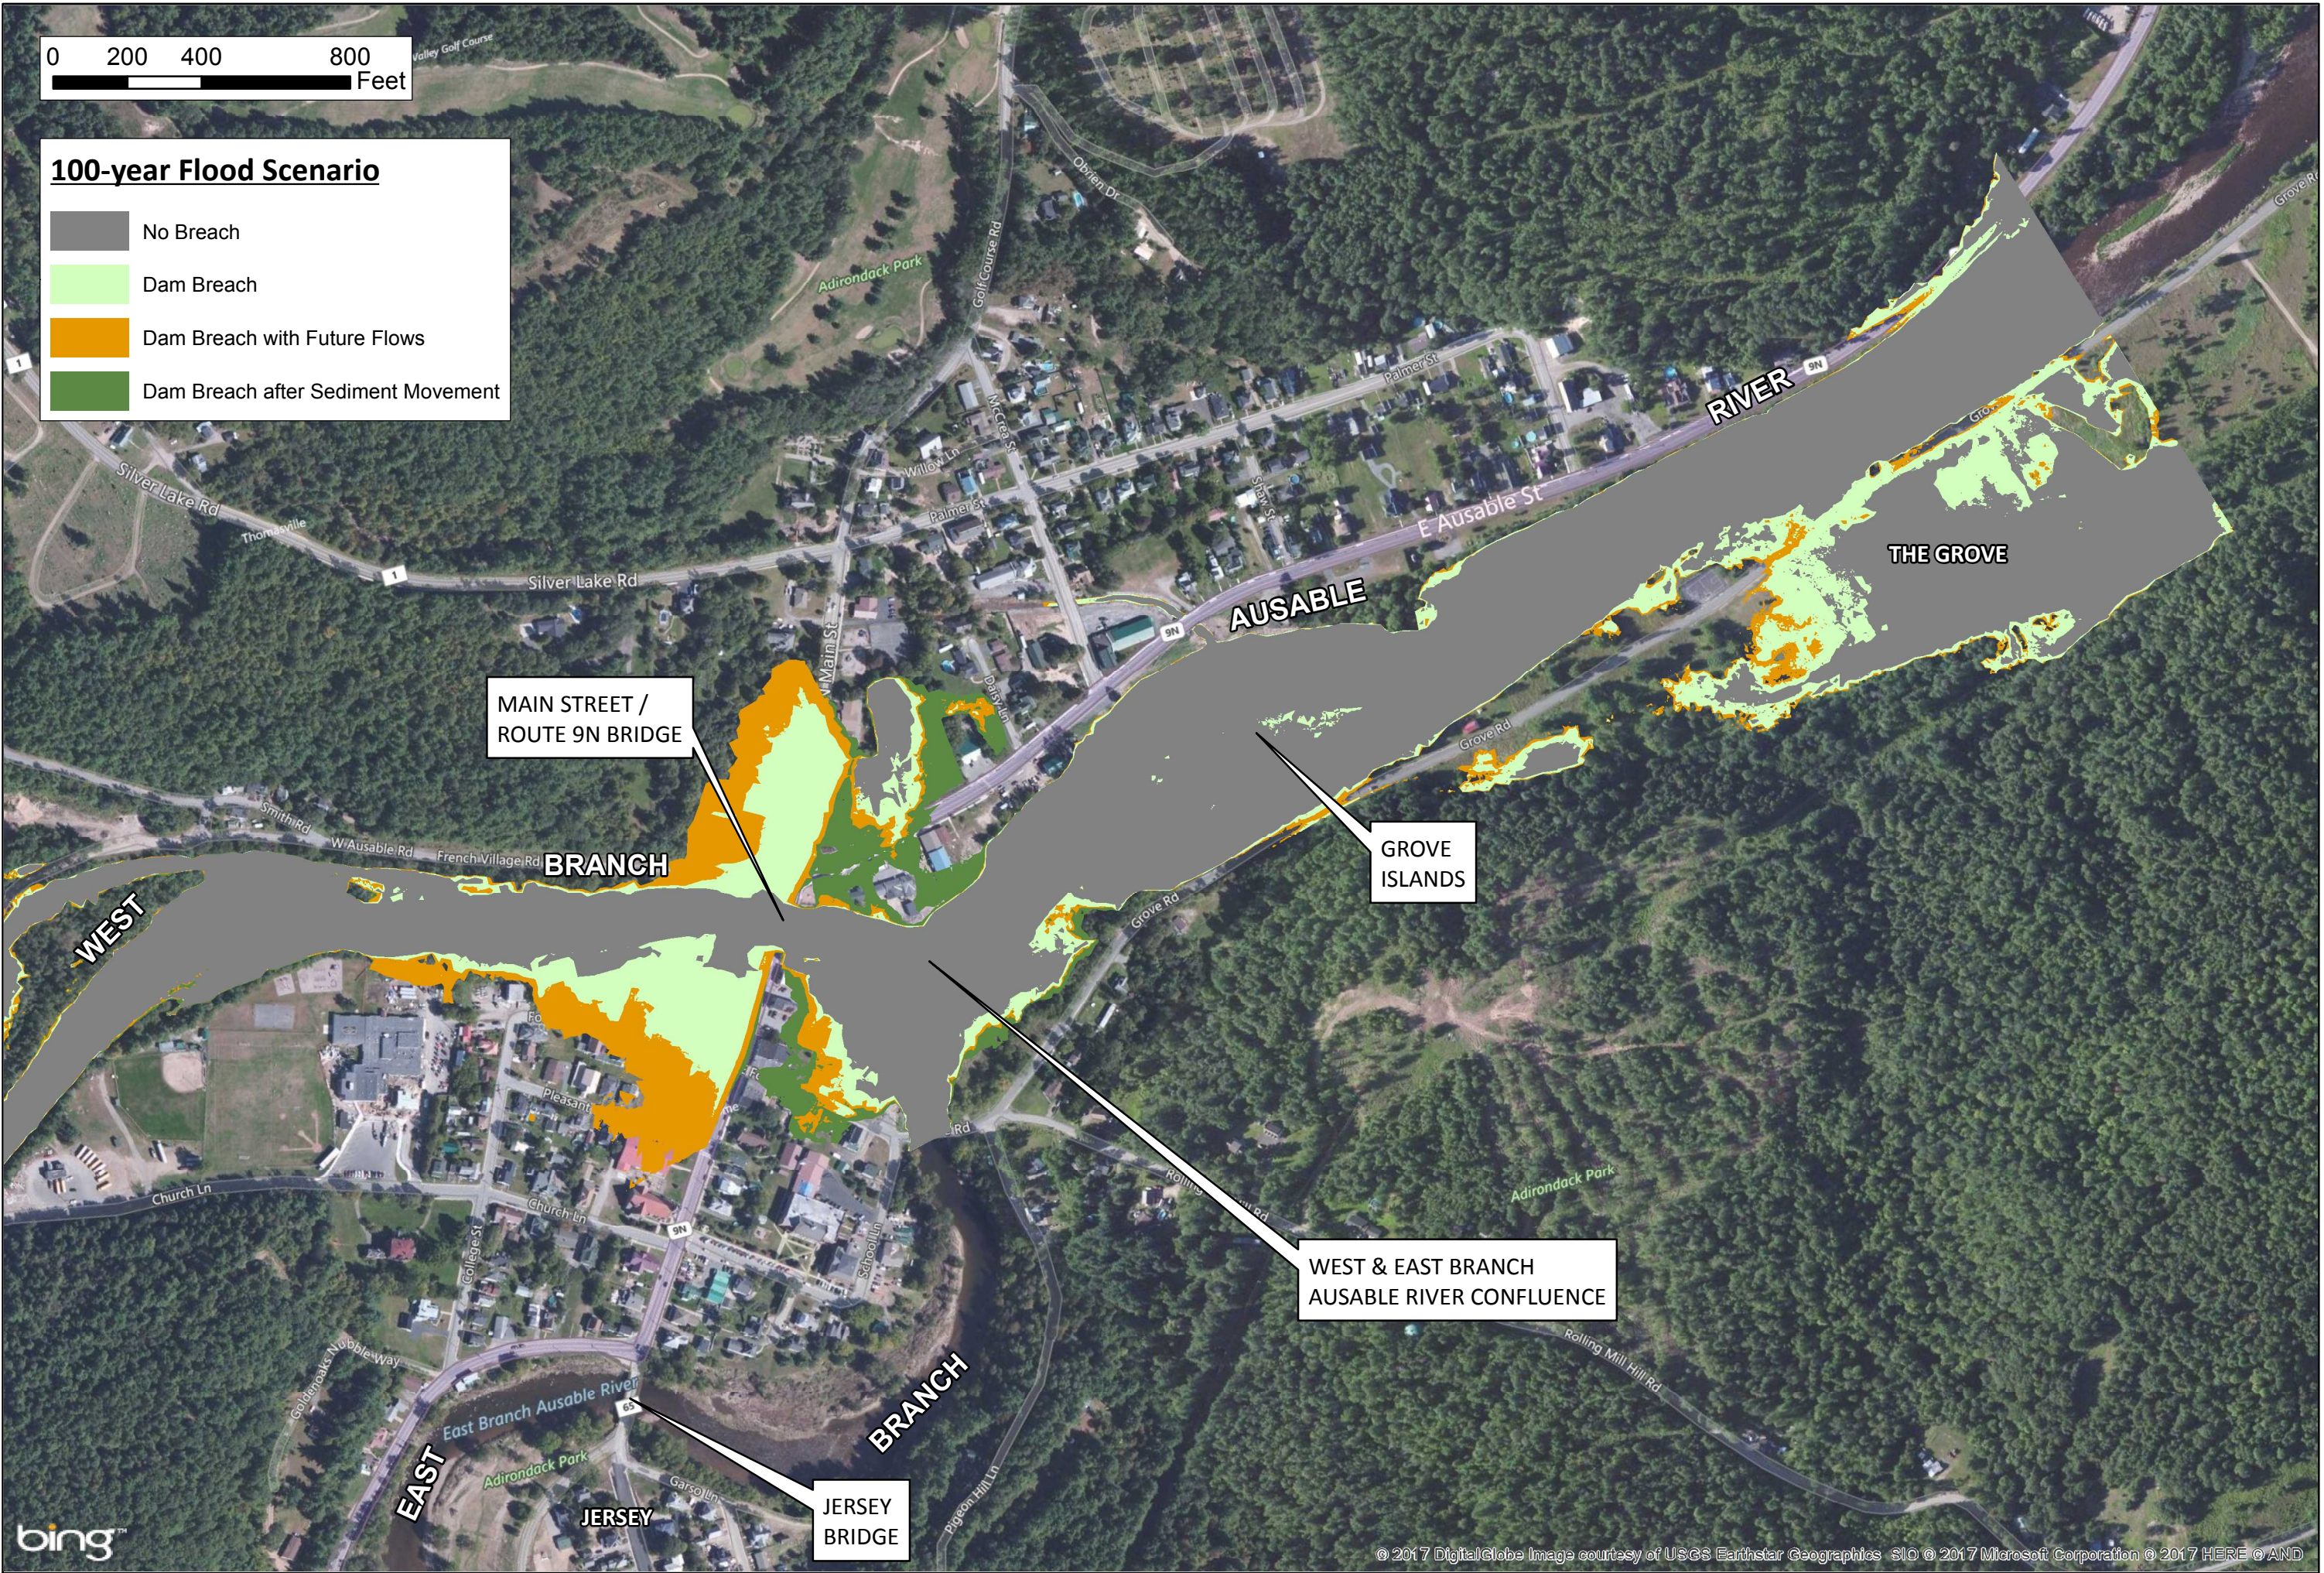
| <b>Figure 4B</b> | | | |

**100-year Flood Scenario**

- No Breach
- Dam Breach
- Dam Breach with Future Flows
- Dam Breach after Sediment Movement

| <b>DAM BREACH INUNDATION MAP - 100-YR FAILURE</b> | | <b>ROMIE DAM ENGINEERING STUDY</b> | <b>JAY, NEW YORK</b> |

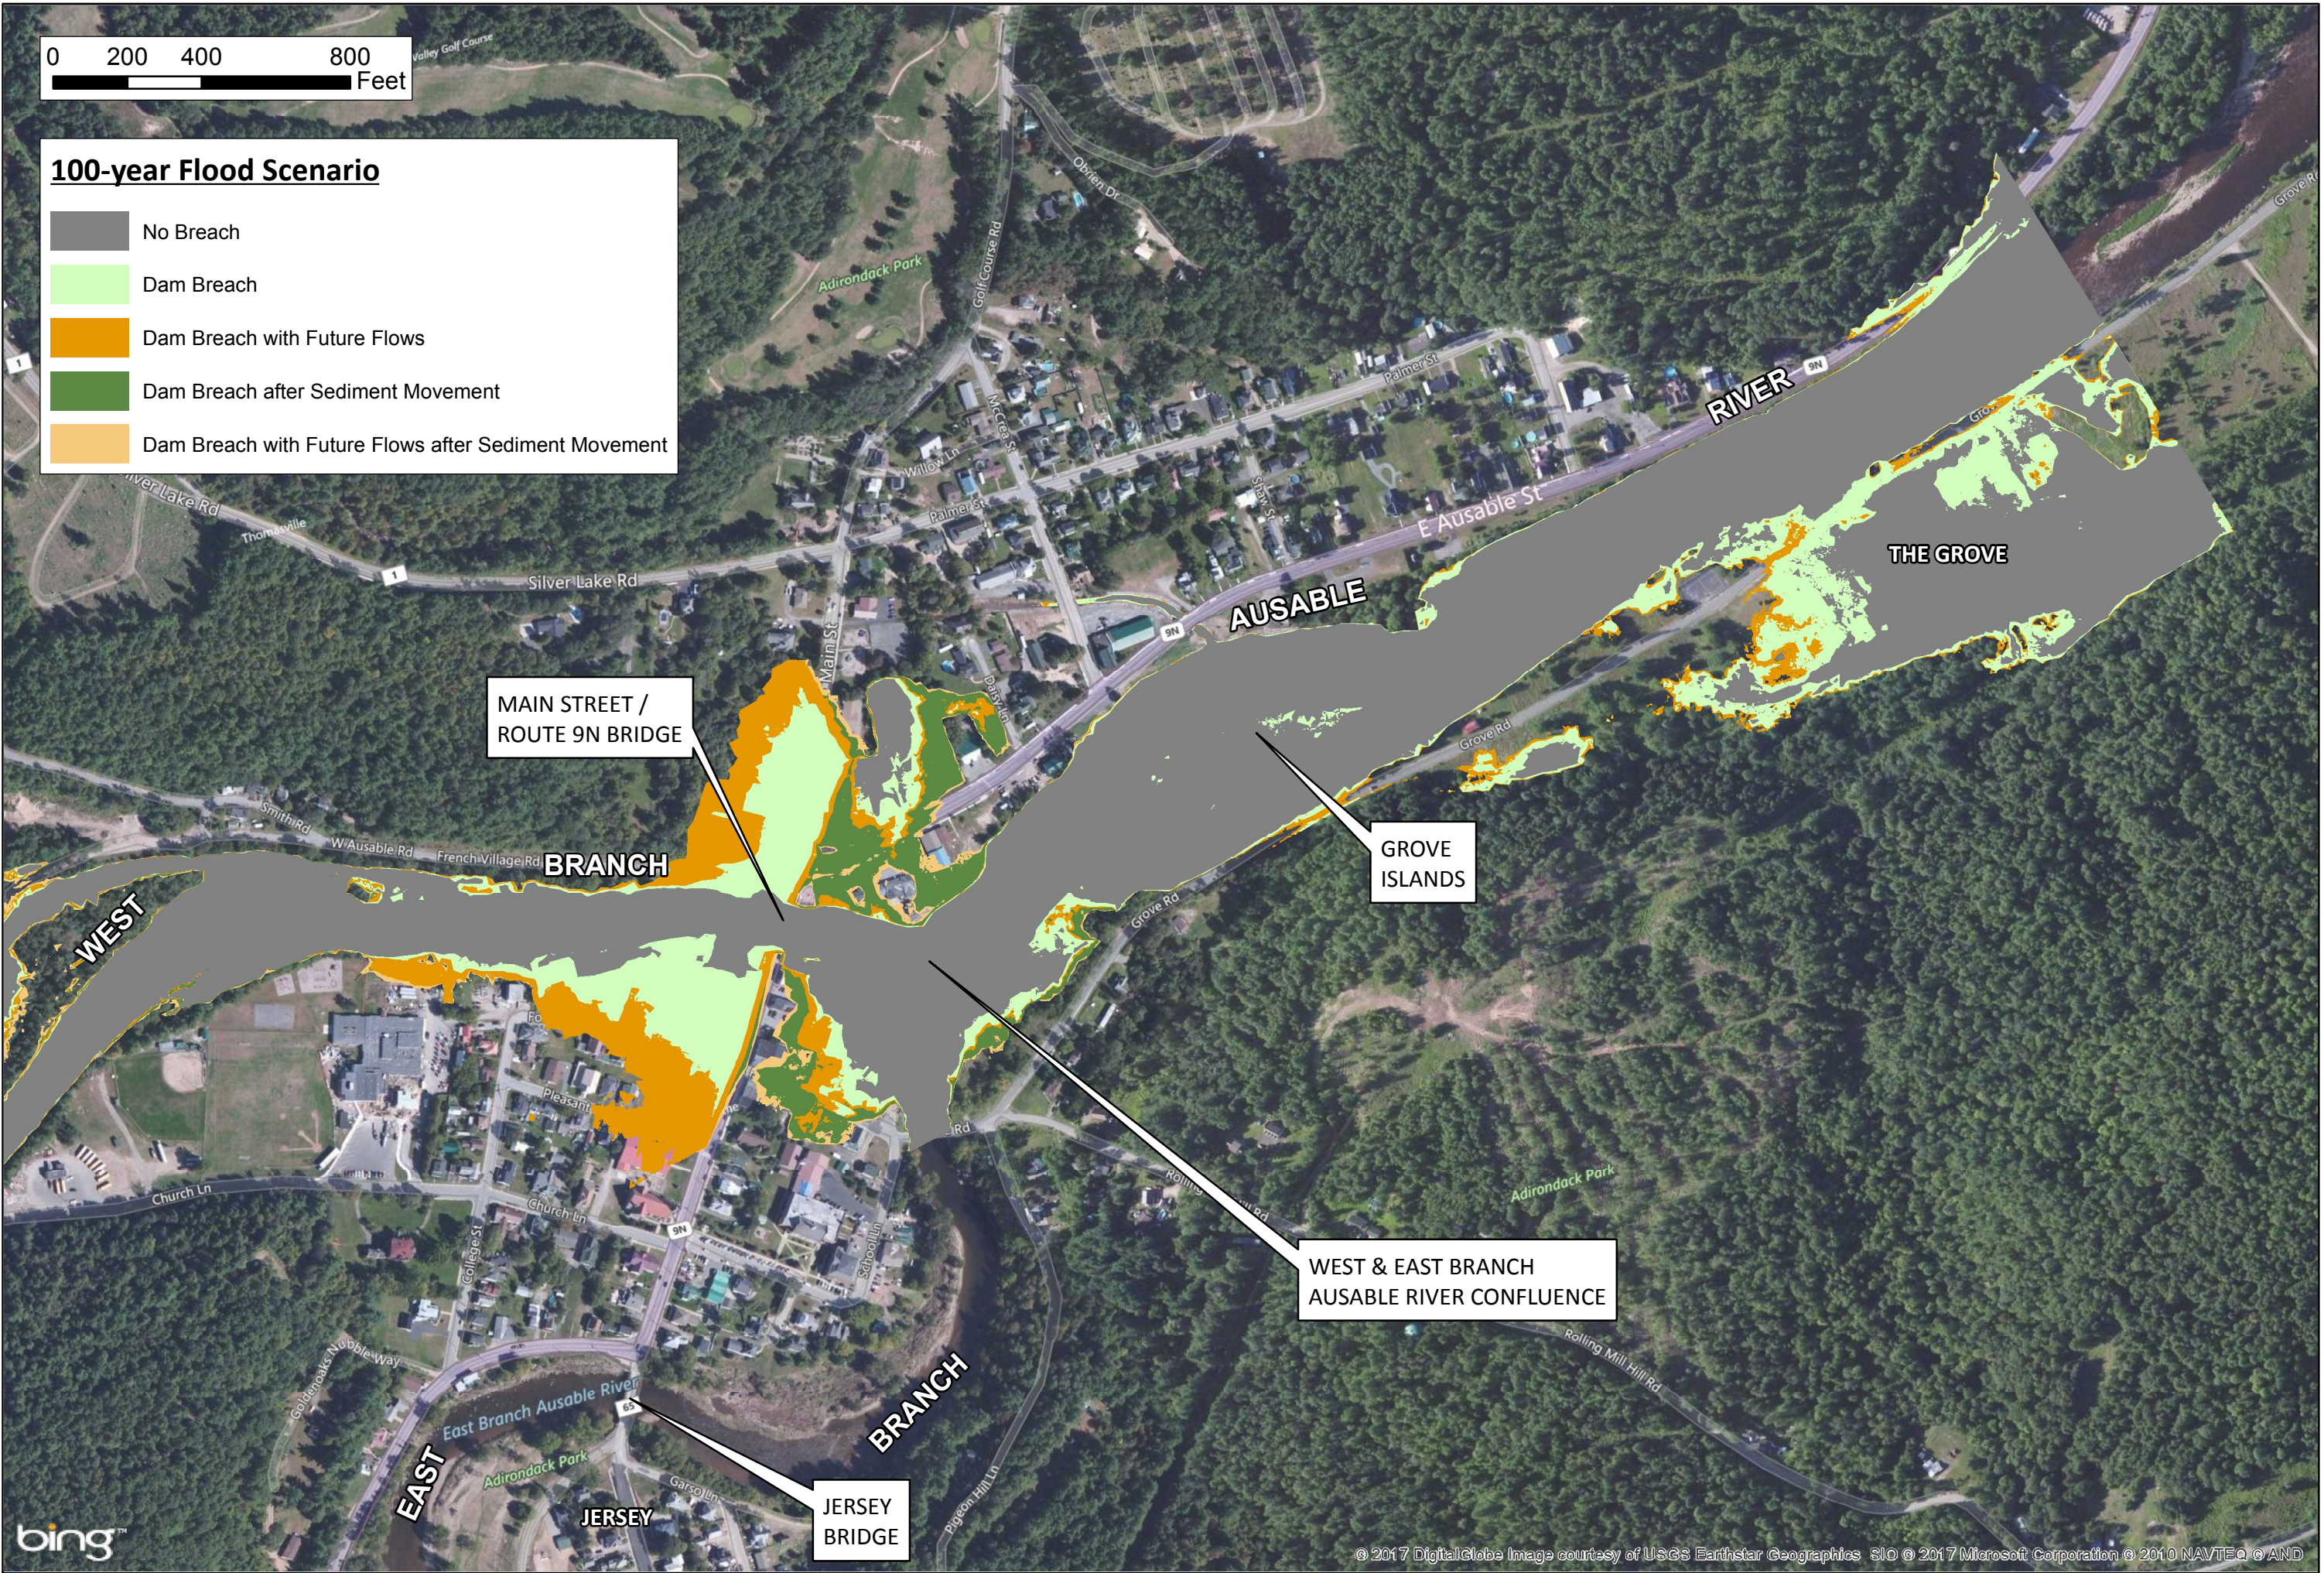
| <b>Figure 5B</b> | | | |

**100-year Flood Scenario**

- No Breach
- Dam Breach
- Dam Breach with Future Flows
- Dam Breach after Sediment Movement
- Dam Breach with Future Flows after Sediment Movement

| <b>DAM BREACH INUNDATION MAP - 100-YR FAILURE</b> | | <b>ROME DAM ENGINEERING STUDY</b> | <b>JAY, NEW YORK</b> |
